Newport Municipal Airport Obstruction Removal

NEWPORT MUNICIPAL AIRPORT OBSTRUCTION REMOVAL PROJECT, LINCOLN COUNTY, OREGON

Cultural Resources Assessment

January 2022

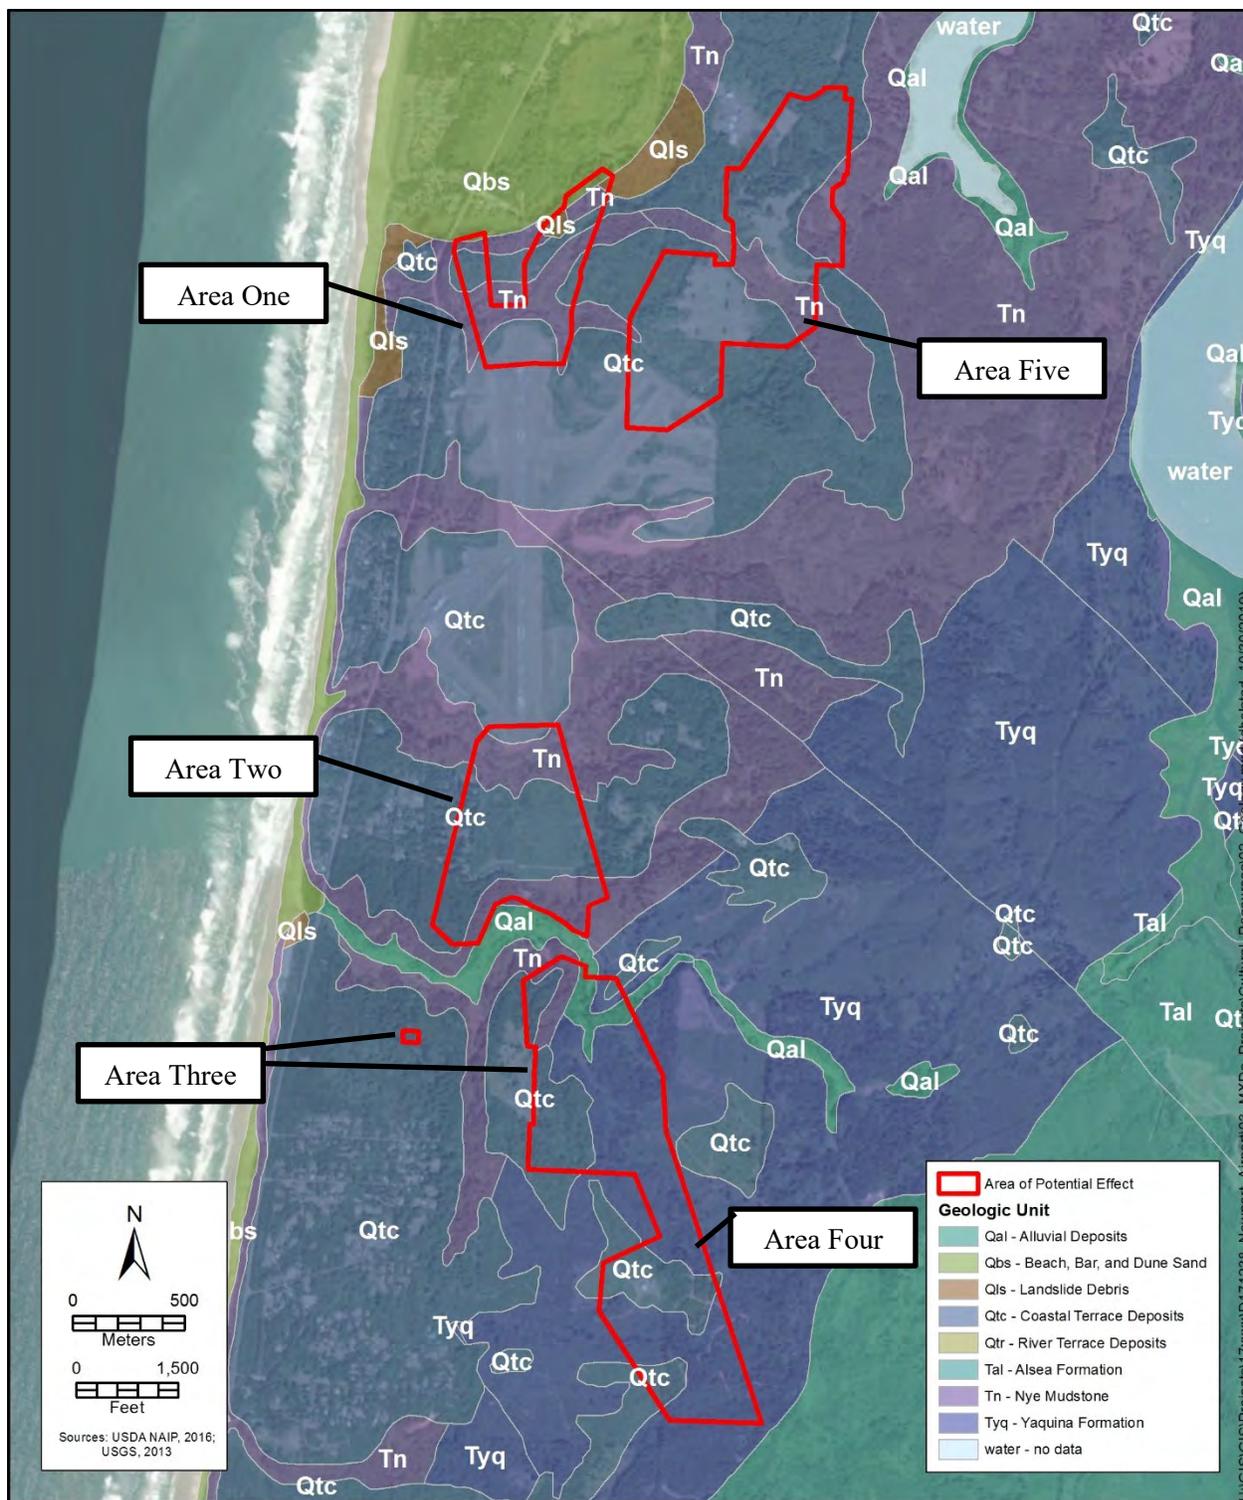
Figure 3
Geological Map of Newport Municipal Airport Obstruction Removal Project

The five APE locations consist predominantly of Coastal Terrace Deposits (Qtc) (Figure 3). However, a wide range of secondary geological units are found across the APE. Nye Mudstone (Tn) can be found in four of the five APE segments, with only the most southern segment not containing this unit. Mudslide debris (Qls) is found exclusively in the north western most APE segment, Area One. The south-central most APE segment, Area Three, represents the most diverse collection of geologic units, including the largest representation of Yaquina (Tyq) and the only representation of alluvial deposits for the project, (Qal) from Thiel Creek. Yaquina is a sandstone and depending on its elevation can be either a micaceous blue-grey sandstone or a coarse-grained buff-colored sandstone (Harrison and Eaton 1920).

The age of deposition for the Nye Mudstone (formed during the Miocene, 23 to 5 million years ago), and the Yaquina Formation (formed during the Paleogene, 66 to 23 million years ago) suggests that neither of these geologic formations would be suitable candidates to retain archaeological resources because they predate human occupation. The coastal deposits, having been possibly windblown from the nearby beach are also less likely to contain archaeological resources. There is also a low probability that the mudslide debris could have buried some cultural material. The only geologic unit within this project that has the likelihood of burying and preserving some cultural material is the alluvial deposits (Qal) from Thiel Creek. These deposits are confined to the deeply incised channel of the creek. The steep topography of the incised channel has resulted on no appreciable flood plain or terrace deposits being associated with the drainage within the APE. Alluvial deposition here is the result of the erosion of the Nye Mudstone to the east. Material has been deposited as the creek flows westward to the ocean. This seasonal high flow energy combined with a restricted incised channel makes it unlikely that this Holocene aged alluvium contains cultural resources.

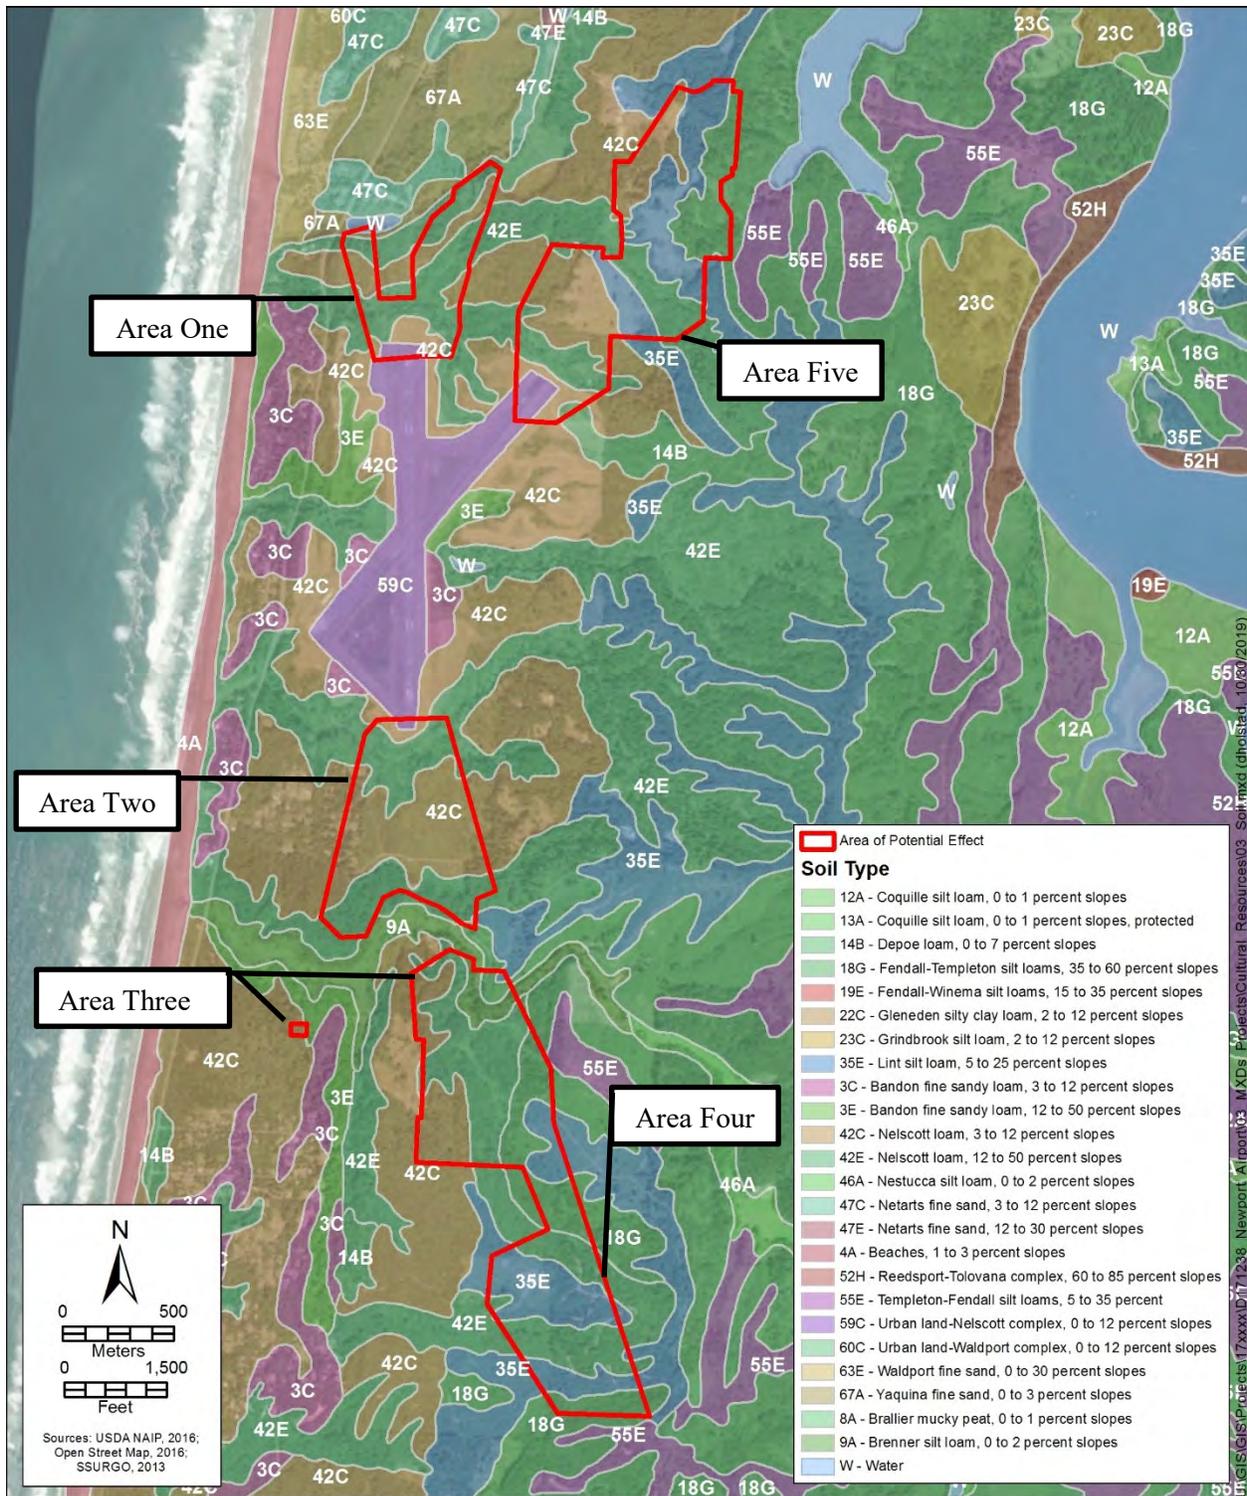
Figure 4
Soils Map of Newport Municipal Airport Obstruction Removal

The Area One and Area Two share the Nelscott loam soil type with a mild variation in slope percentages ranging from 42E: 12 to 50 percent slope, 42 C: 3 to 12 percent slopes, and 59C: 0 to 12 percent slopes. The description for 59C also includes a mixture of urban land and the Nelscott complex. Consisting of moderately well drained soils overlying stratified marine sediments, this soil series is found on marine terraces and have a mean annual precipitation of about 70 inches (National Cooperative Soil Survey 2003). The taxonomic description for these soils are “fine-loamy over sandy or sandy-skeletal, isotic over mixed, isomesic, ortstein Typic Durorthods” (National Cooperative Soil Survey 2003).

The greatest variation in soil types within the project is found Area Three and Area Four, which make up the southern portion of the APE. In this location two Nelscott loam types are present (42C and 42E), but also three other silt loam soil types: the Fendall-Templeton silt loam with a 35 to 65 percent slope (18G), the Lint silt loam, with 5 to 25 percent slope (35E), and the Brenner silt loam with 0 to 2 percent slopes (9A). Each of these additional three soil types are discussed separately below. The Fendall series can be found on coastal hills, mountains, and old dissected marine terraces consisting of “fine, isotic, isomesic Andic Humudepts” (National Cooperative Soil Survey 2011). While the texture consists of more than 35 percent of clay regularly, when factoring in the Templeton soils, this average drops to less than 35 percent of clay in the texture control section of the soil (National Cooperative Soil Survey 2011). The Lint series has a small distribution located only on the coastal area of Oregon and are “formed in alluvium weathered mostly from sedimentary rocks” (National Cooperative Soil Survey 2000b). The final soil series that is associated with this project includes the Brenner Series. Unlike the other soils discussed in this section, the poorly drained Brenner series is found in swales on flood plains adjacent to stream terraces, and are formed in silty mixed recent alluvium that are the result of basic igneous and sedimentary rocks (National Cooperative Soil Survey 2004). This alluvial soil is only found in Area three, the northern half of the Southern APE polygon.

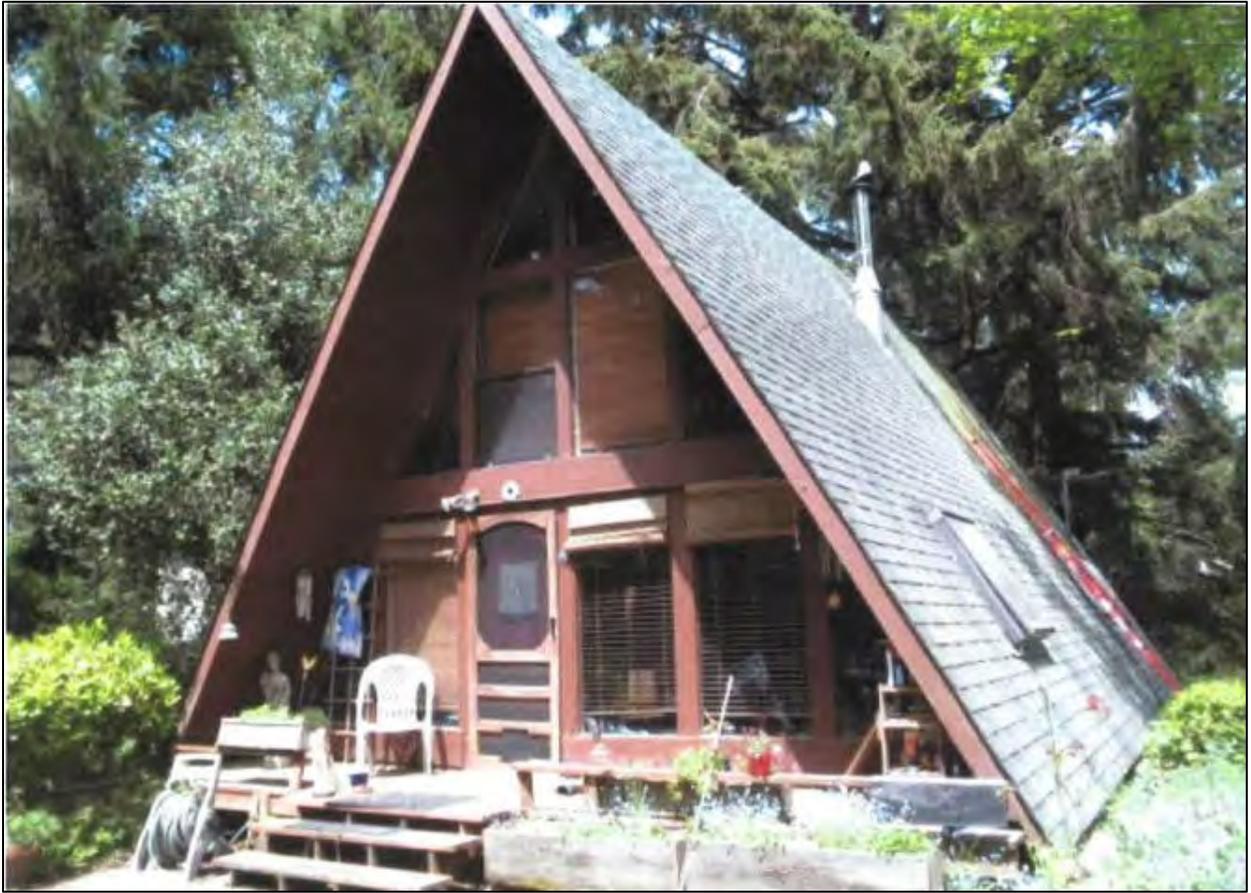
The residence at 425 SE 98th Street is located in South Beach, Lincoln County. ESA did not have Rights of Entry to the property and observed the structure from the public Right of Way. The county assessor lists the construction date as 1964. This residence is a south-facing 1½-story wood A-frame structure with a steep gabled roof that extends to the ground (Figure 5). The house is set back from SE 98th Street. The roof features composition shingles with enclosed eaves. There is a metal chimney present on the west facade and multiple skylights within each of the sloping rooves. The foundation was not visible from the street. Exterior walls are clad with wood frame, and a mix of single-hung and picture windows. There is a wood deck that extends the length of the front façade. The county assessor has no changes to the structure on file.

At a reconnaissance level of evaluation, this residence retains some architectural integrity of design, materials, workmanship, and feeling consistent with its contemporary folk A-Frame design (e.g. steeply sloped roofline extending to the structure's foundation, wooden siding). However, the roof has been replaced with asphalt shingles and the skylights appear to be replacements based on observable materials. Additionally, the porch is of simple construction, and no second story balcony is present, as is found in other examples of the style. These conditions diminish its overall integrity, and it does not appear to be an outstanding example of the style. However, a full documentation of the structure would be required to make a conclusive determination. As a result, ESA recommends that the property be considered Potentially Eligible for the NRHP, based on its architectural style and materials (Criterion C), until a full documentation is completed. No connection to local, regional or national events (Criterion A), or important person's (Criterion B), was revealed during the archival research into the original builder or past residents. Finally, as a typical mid-20th century single family residence, the structure does not possess the ability to provide new information about history or prehistory (Criterion D).

Figure 5
425 SE 98th Street, front facade, view to the North

The proposed project impacts, of tree clearing, will not impact the structure or its setting. The parcel is adjacent to active logging land and tree clearing has been occurring in the area before the structure was built and throughout its existence. As a result, ESA recommends that the project will not have an adverse effect to the property.

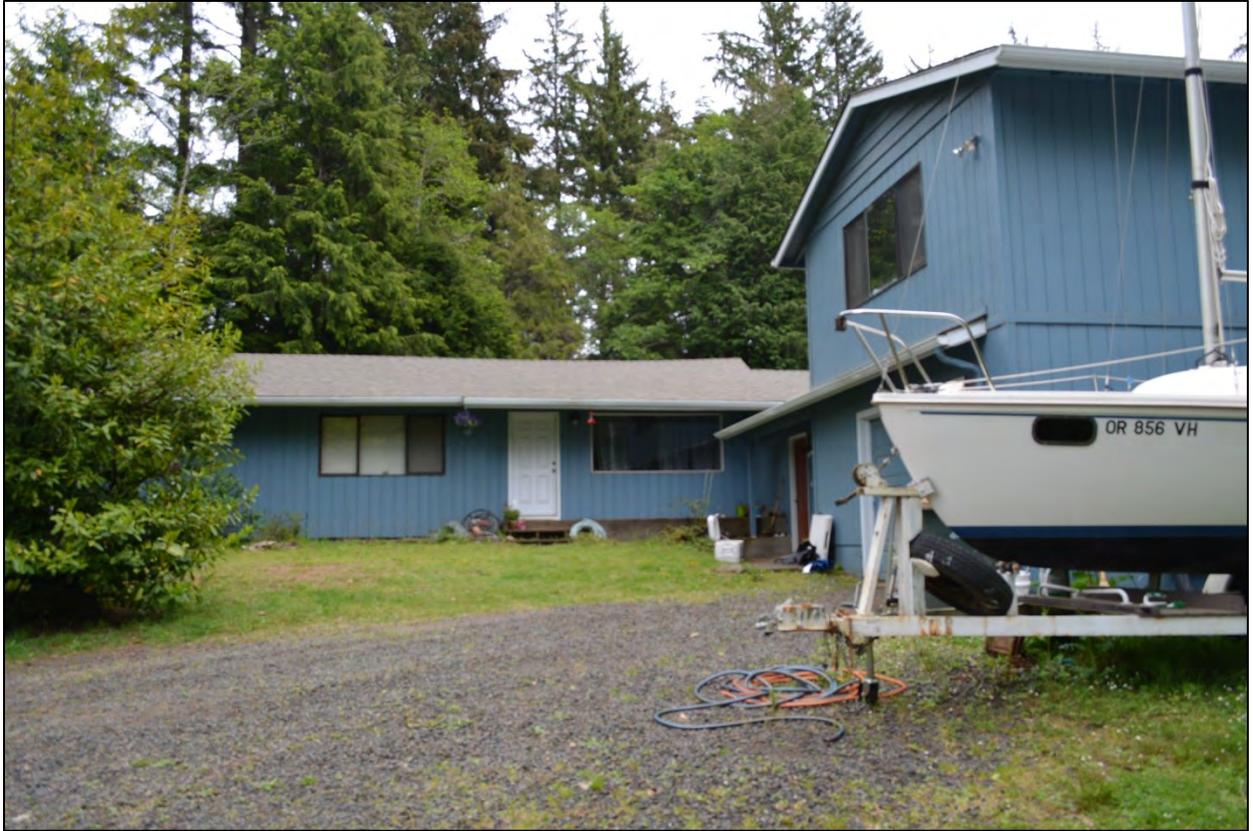
The residence at 585 SE 98th Street, South Beach, is located in Lincoln County. The county assessor lists the construction date as 1970. This residence is a southwest facing 1-story wood frame structure with an L-shape plan and cross-gabled roofline at the rear façade, with open eaves (Figure 6). The attached 2-story garage has a front-gable roof line with open eaves. It is set back from SE 98th Street. The roof is clad with composition shingles; no chimneys are present. The foundation is poured concrete. Exterior walls are clad in wood vertical board and horizontal clapboard at the roofline. The front entry is in the center of the west facade with a secondary entry to the south. There are slider windows with metal frame throughout. There is a small deck off the rear / east facade. According to the county assessor the garage with second floor addition was constructed ca. 1979/1980. A portion of the garage was converted to living space at that time.

The structure appears to originally been a single-story contemporary ranch design that was later extensively remodeled. While the addition maintains the same T-111 siding as the original structure, the two story addition obscures the original historic aged structure. It now more closely resembles a split level design, rather than a ranch. These conditions diminish its overall integrity, and it does not represent an outstanding example of its original style. ESA recommends that the property be considered Not Eligible for the NRHP based on its architectural style and materials (Criterion C). No connection to local, regional or national events (Criterion A), or important person's (Criterion B), was revealed during the archival research into the original builder or past residents. Finally, as a typical mid-20th century single family residence, the structure does not possess the ability to provide new information about history or prehistory (Criterion D).

The proposed project impacts, of tree clearing, will not impact the structure or its setting. The parcel is adjacent to active logging land and tree clearing has been occurring in the area before the structure was constructed and throughout its existence. As a result, ESA recommends that the project will not have an adverse effect to the property.

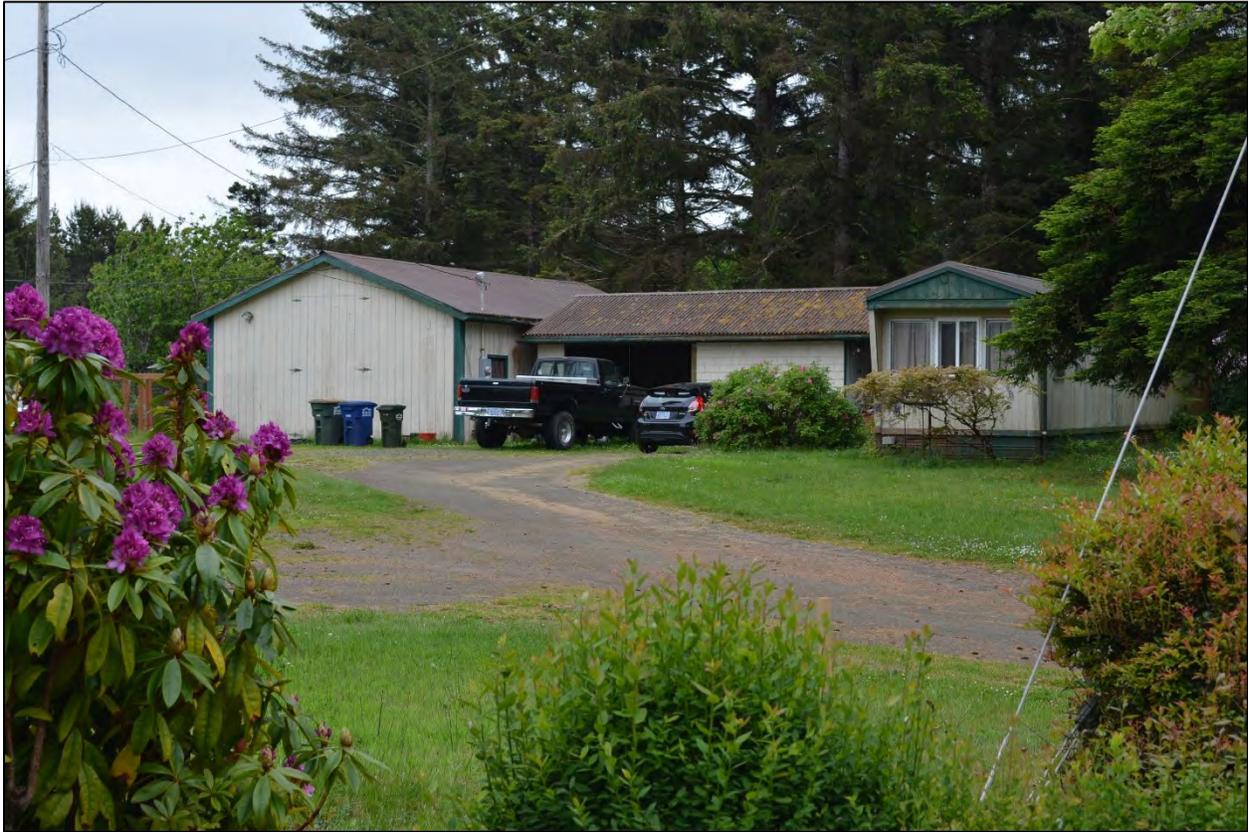
The residence at 9435 SE Cedar Street, South Beach, is located in Lincoln County. ESA did not have Rights of Entry to the property and observed the structure from the public Right of Way. The county assessor lists the construction date as 1962. This residence is a northeast facing 1-story single wide manufactured home with a detached garage / shop approximately 24 feet x 44 feet (Figure 7). The county assessor has no known build date for the garage. The serial number for the manufactured home is E55DC22625. The exterior of the home is metal with slider windows. The addition to the mobile home appears to be constructed of two separate structures. One is constructed with metal siding and the other is wooden shingles. Both have corrugated metal rooves, but of dissimilar materials.

The original mobile home appears to have been remodeled, containing both original aluminum and later vinyl frame windows. The additions to the structure are of incongruous design and materials, neither of which match the primary dwelling. These conditions diminish its overall integrity, and it does not represent an outstanding example of its original style. ESA recommends that the property be considered Not Eligible for the NRHP; however, a full documentation of the structure would be required to make a conclusive determination. As a result, ESA recommends that the property be considered Not Eligible for the NRHP based on its architectural style and materials (Criterion C). No connection to local, regional or national events (Criterion A), or important person's (Criterion B), was revealed during the archival research into the original builder or past residents. Finally, as a typical mid-20th century single family residence, the structure does not possess the ability to provide new information about history or prehistory (Criterion D).

The proposed project impacts, of tree clearing, will not impact the structure or its setting. The parcel is adjacent to active logging land and tree clearing has been occurring in the area before the structure was constructed and throughout its existence. As a result, ESA recommends that the project will not have an adverse effect to the property

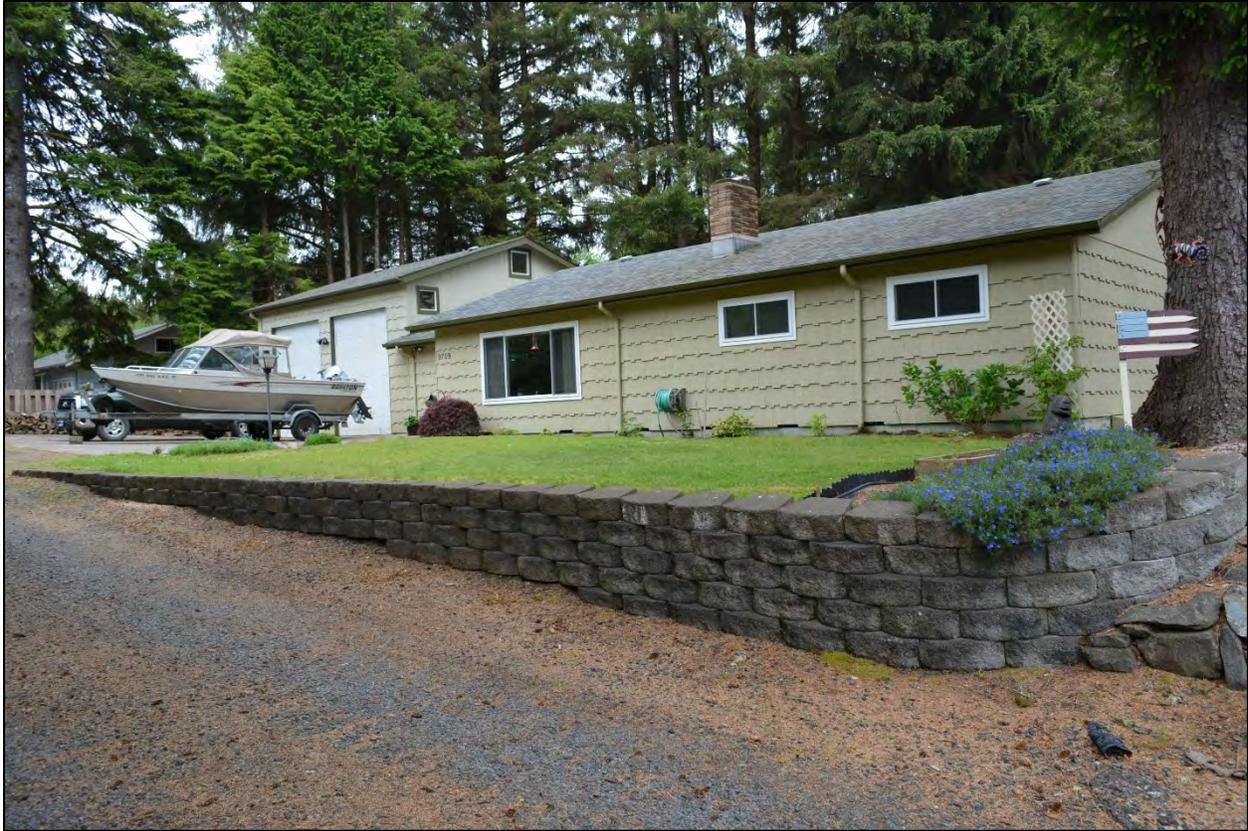
The residence at 9709 SE Cedar Street, South Beach, is located in Lincoln County. The county assessor lists the construction date as 1967. This residence is a north facing 1-story rectangle plan structure with a side-gable roofline and attached 2-car garage (Figure 8). It shares a private drive off the east side of SE Cedar Street. The roof is clad with composition shingles and open eaves. There is a brick chimney present. The foundation is poured concrete. Exterior walls are covered with decorative patterned wood shingle and wood vertical board at the roofline on the west facade and wood vertical board on the east facade/garage. The front entry is setback and offset to the east of the north façade and features a wood door with three small diagonal windows. There are vinyl slider windows on the house and single pane windows on the garage. There is a small shed clad in wood horizontal clapboard with a front gable roofline to the west of the house. The county assessor lists the original garage as being removed and replaced with the current garage in 2004.

The original single story ranch style home has been remodeled. The windows have been replaced with modern vinyl, and the garage has been demolished and replaced with a structure that no longer matches the original roofline or dimensions of the home. The roof appears to have been replaced with asphalt shingles. It is not clear if the wooden siding is original or a replacement, the assessor was not able to provide photographs of the original structure. These conditions diminish its overall integrity, and it does not represent an outstanding example of its original style. ESA recommends that the property be considered Not Eligible for the NRHP based on its architectural style and materials (Criterion C). No connection to local, regional or national events (Criterion A), or important person's (Criterion B), was revealed during the archival research into the original builder or past residents. Finally, as a typical mid-20th century single family residence, the structure does not possess the ability to provide new information about history or prehistory (Criterion D).

Figure 8
9709 SE Cedar Street, front facade, view

The proposed project impacts, of tree clearing, will not impact the structure or its setting. The parcel is adjacent to active logging land and tree clearing has been occurring in the area before the structure was constructed and throughout its existence. As a result, ESA recommends that the project will not have an adverse effect to the property

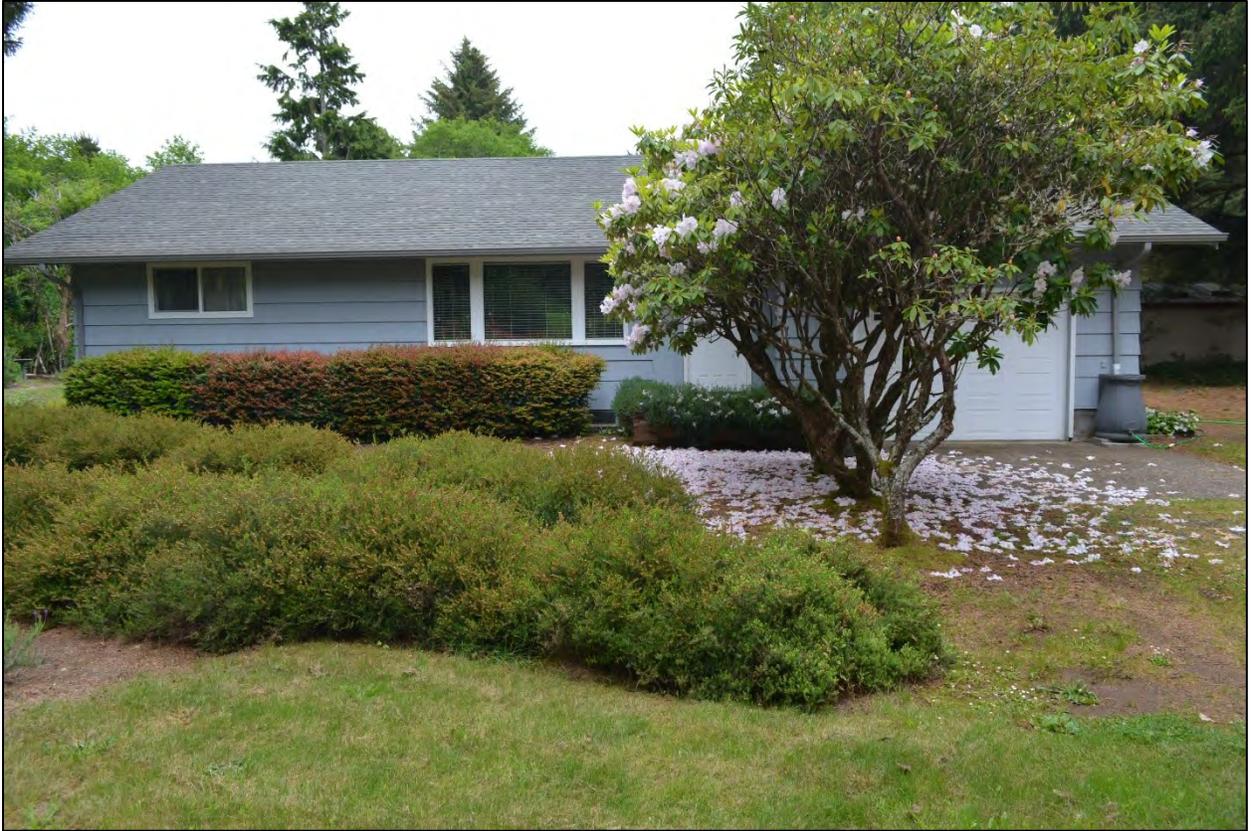
The residence at 9711 SE Cedar Street, South Beach, is located in Lincoln County. The county assessor lists the construction date as 1966. This residence is a north facing 1-story structure with a cross-gable roofline and attached 1-car garage (Figure 9). It shares a private drive off the east side of SE Cedar Street. The roof is clad with composition shingles and open eaves. There is a brick chimney present. The foundation is poured concrete. Exterior walls are covered with cedar shingle, decorative vertical board at the roofline and wood vertical board at the foundation. The front entry is offset to the west of the north façade and features a wood six paneled door. The rear entry includes a small concrete porch with sliding glass door. There are vinyl and metal slider windows on the residence. The county assessor has no permits or changes on file for the structure.

The structure maintains its original single story ranch floorplan. Some of the windows have been replaced and the composition shingle roof appears to be a replacement. These conditions diminish its overall integrity, how it still retains its general original form it does not represent an outstanding example of its original style. The home appears to be well maintained, but does not represent exemplary construction or materials. ESA recommends that the property be considered Not Eligible for the NRHP based on its architectural style and materials (Criterion C). No connection to local, regional or national events (Criterion A), or important person's (Criterion B), was revealed during the archival research into the original builder or past residents. Finally, as a typical mid-20th century single family residence, the structure does not possess the ability to provide new information about history or prehistory (Criterion D).

The proposed project impacts, of tree clearing, will not impact the structure or its setting. The parcel is adjacent to active logging land and tree clearing has been occurring in the area before the structure was constructed and throughout its existence. As a result, ESA recommends that the project will not have an adverse effect to the property

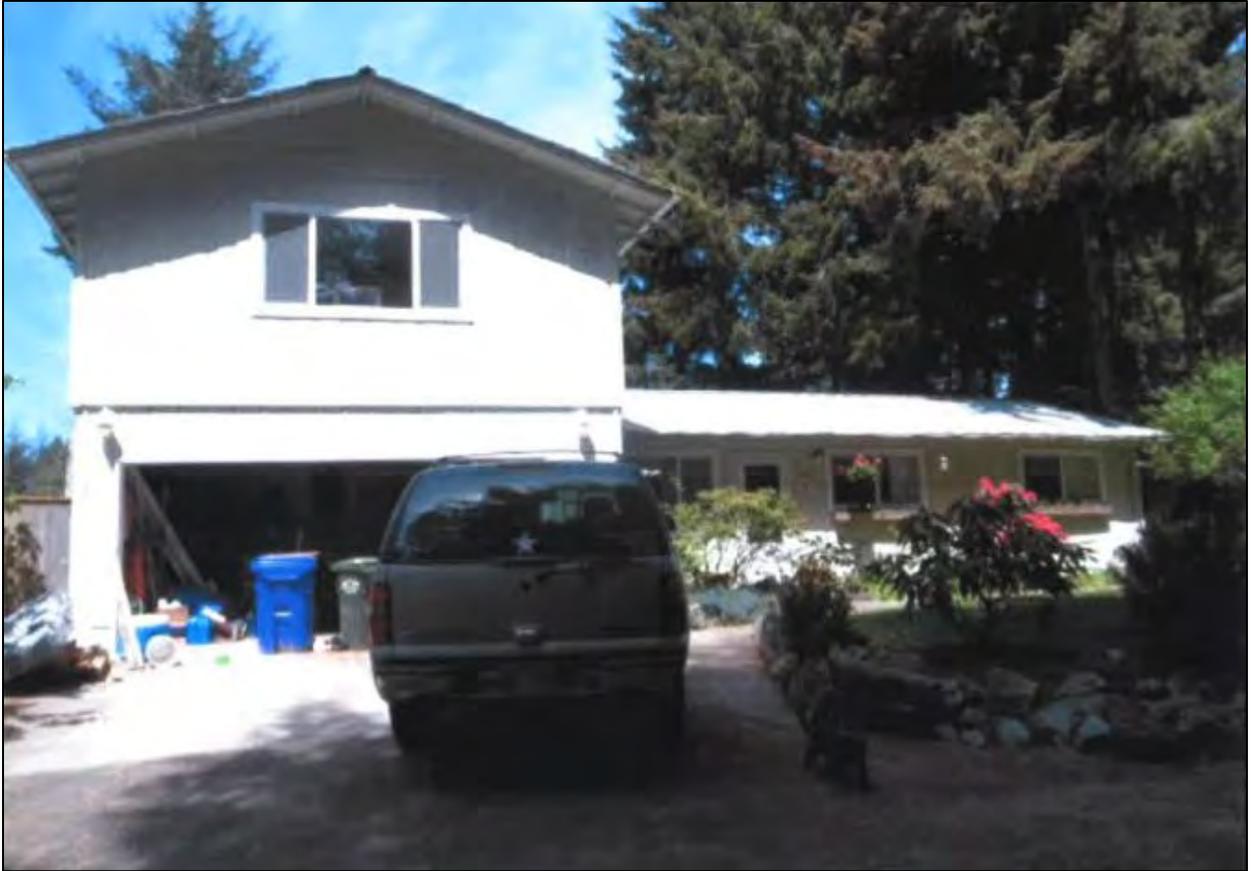
The residence at 9735 SE Cedar Street, South Beach, is located in Lincoln County. The county assessor lists the construction date as 1967. ESA did not have Rights of Entry to the property and observed the structure from the public Right of Way. . This residence is a south facing 2-story structure with a cross-gable roofline and attached 2-car garage (Figure 10). It shares a private drive off the east side of SE Cedar Street. The roof is clad with composition shingles and open eaves. There is a brick chimney present on the west facade. The foundation is poured concrete. Exterior walls are covered with vertical board and horizontal clapboard at the roofline. The front entry is offset to the east of the south façade. There are vinyl and metal slider windows on the residence. The county assessor lists a second story addition in 1982 and 15-foot x 16-foot addition to the east in 2000.

The structure appears to have been originally been a single-story contemporary ranch design that was later extensively remodeled. While the addition maintains the same siding and open gabled roof as the original structure, the two story addition obscures the form of original historic aged structure. These conditions diminish its overall integrity, and it does not represent an outstanding example of its original style. ESA recommends that the property be considered Not Eligible for the NRHP based on its architectural style and materials (Criterion C). No connection to local, regional or national events (Criterion A), or important person's (Criterion B), was revealed during the archival research into the original builder or past residents. Finally, as a typical mid-20th century single family residence, the structure does not possess the ability to provide new information about history or prehistory (Criterion D).

The proposed project impacts, of tree clearing, will not impact the structure or its setting. The parcel is adjacent to active logging land and tree clearing has been occurring in the area before the structure was constructed and throughout its existence. As a result, ESA recommends that the project will not have an adverse effect to the property.

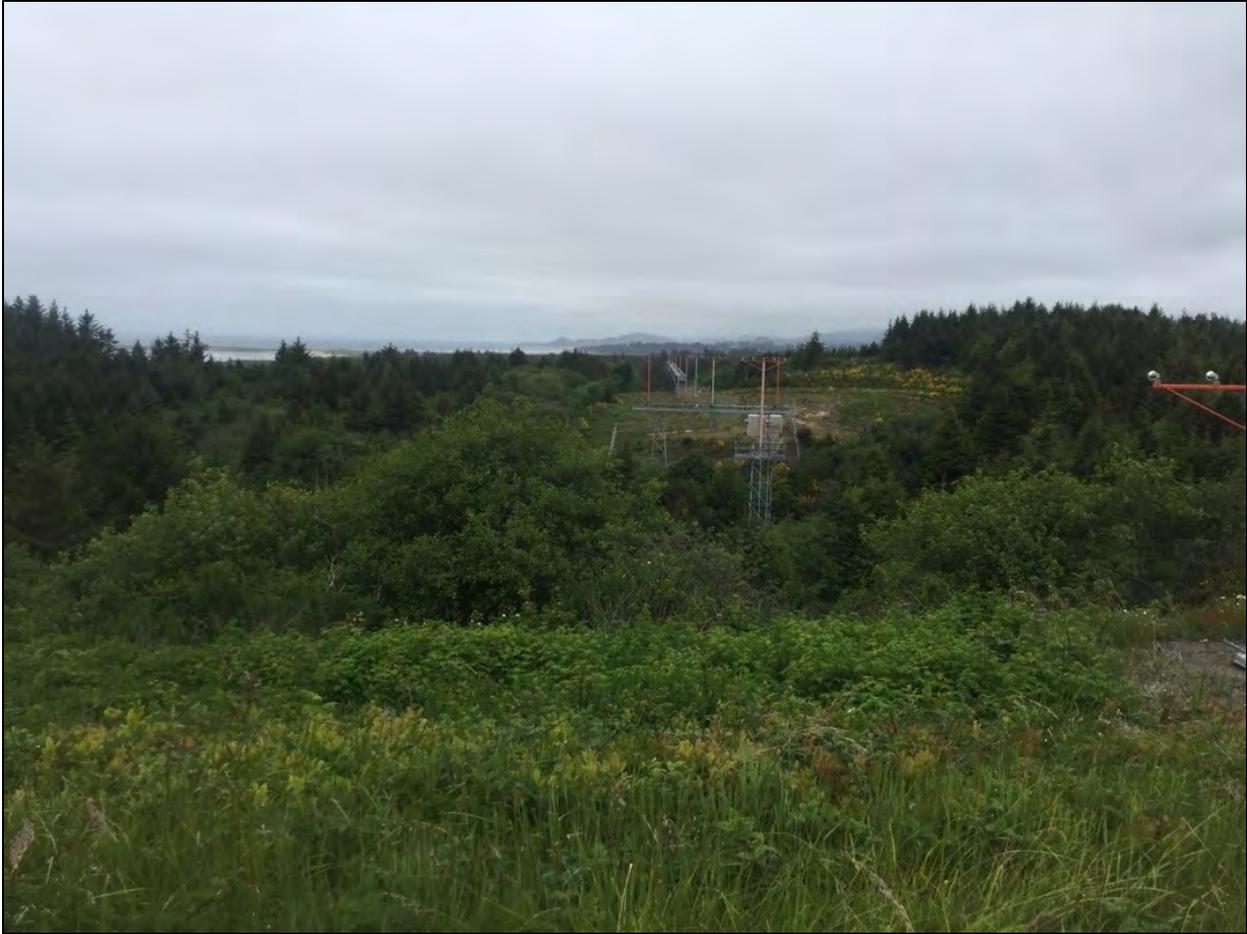
The area north of Runway 16 is much more heavily vegetated. Existing airport infrastructure such as lighting towers are common, and a complex network of established roads and trails provides excellent access. The area is topographically diverse, with steep ridges and deeply incised valleys (Figure 20). Slopes and areas of sparse canopy cover were covered in Oregon grape, while dense areas of young recently logged forest lacked established understory vegetation, and were choked by immature conifers (Figure 21). These areas displayed less than 10% ground visibility. Densely forested areas with established canopy, were rare, but when present, contained very little underbrush and had excellent surface visibility, greater than 50%. These areas were typically found along the higher probability ridge lines. While the slopes were more densely vegetated with less mature trees and understory. The forested northern portions of Area One contained pervasive evidence of logging activity, such as cut stumps, piles of limbing debris, and a network of access trails throughout the landscape.

Figure 20
Overview of Area One from airport, showing existing airport infrastructure and forested ridgelines view to north

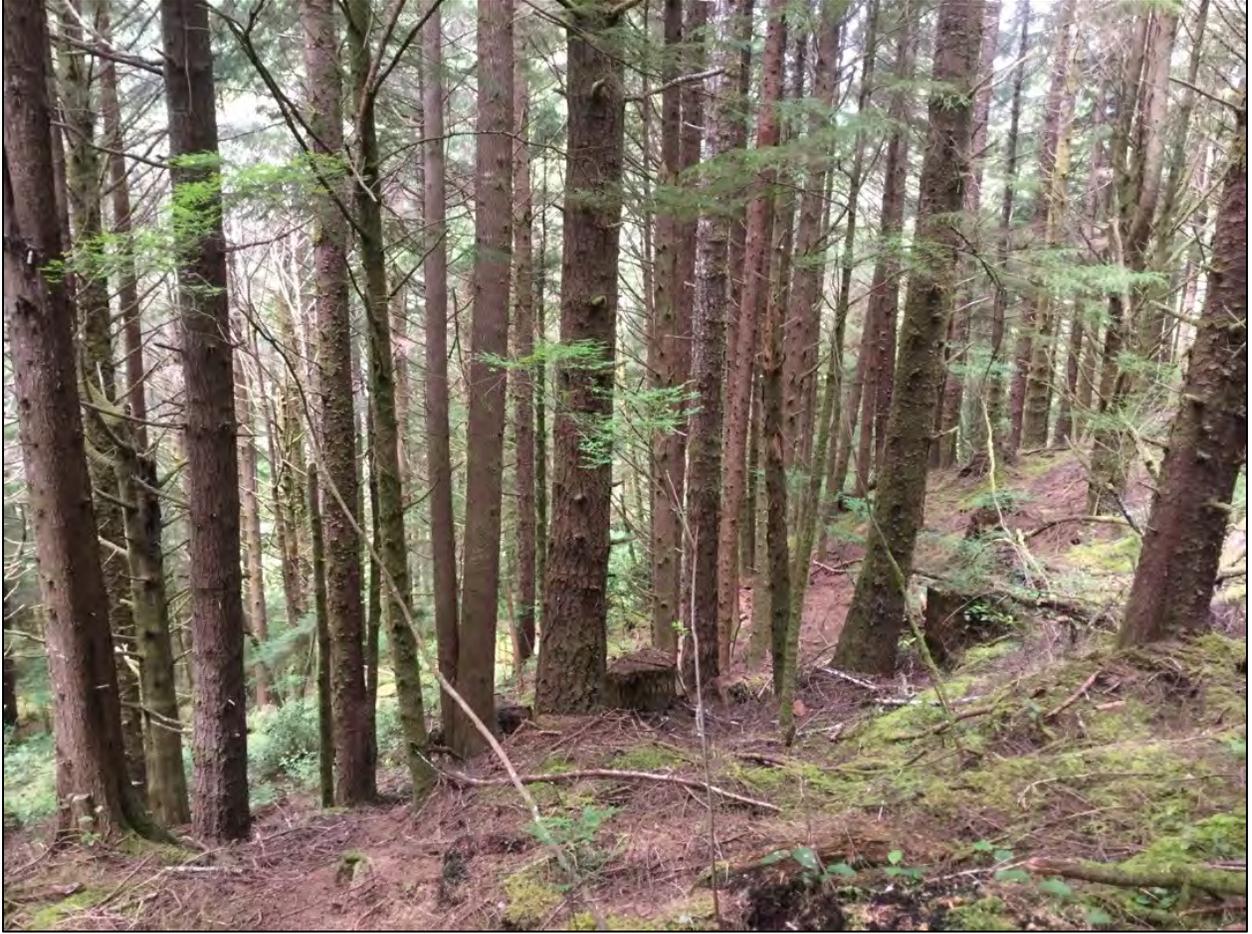
Area Three consists of mature conifer forest. The ground visibility here is moderate to good, between 25-50% visibility. Ridge lines have the best visibility, due to the more densely spaced mature conifers, while slopes, valley bottoms and open sections without forest canopy are more heavily vegetated and have poor visibility. The entire area shows evidence of pervasive disturbance related to logging activity, in the form of cleared staging areas and access roads, and piles of woody debris and common cut stumps. The area is not in close proximity to permanent water bodies. The vast majority of the area is either heavily sloped or occupied by constructed access or staging infrastructure (Figure 25). Higher probability landforms, such as ridgelines and terraces with a view shed are small and uncommon. This area are also often heavily disturbed by previous logging activity (Figure 26).

Figure 25
Overview of steep slopes with established canopy conifer forest typical of Area Three.

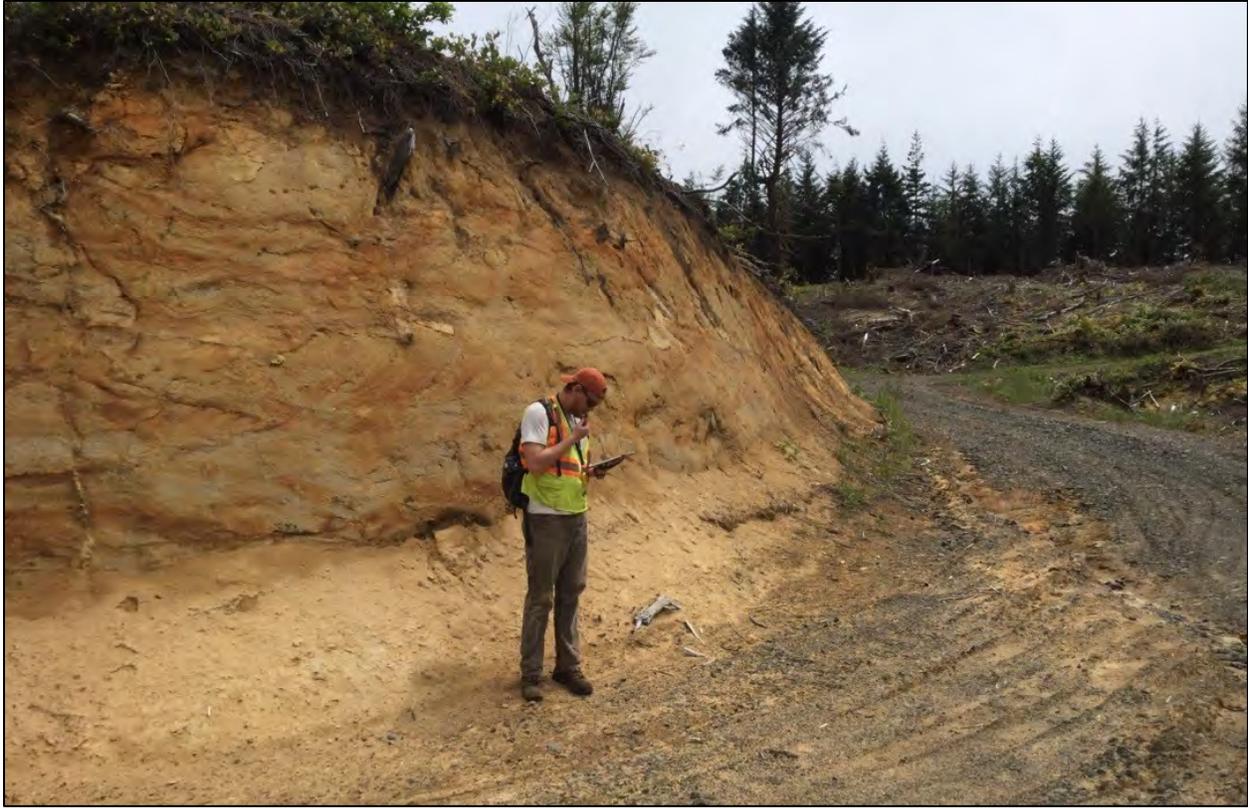
Multiple cut in access roads have exposed the soil matrix present within Area Four. These cut profiles evidence a massive sandy conglomerate of marine deposits. A thinly developed A horizon is present at the surface (Figure 29). No beds of finer grained material were observed. This confirms the mapped geological conditions in the area.

Figure 29
Exposed cut bank in area four showing typical geologic and soils conditions for the area.

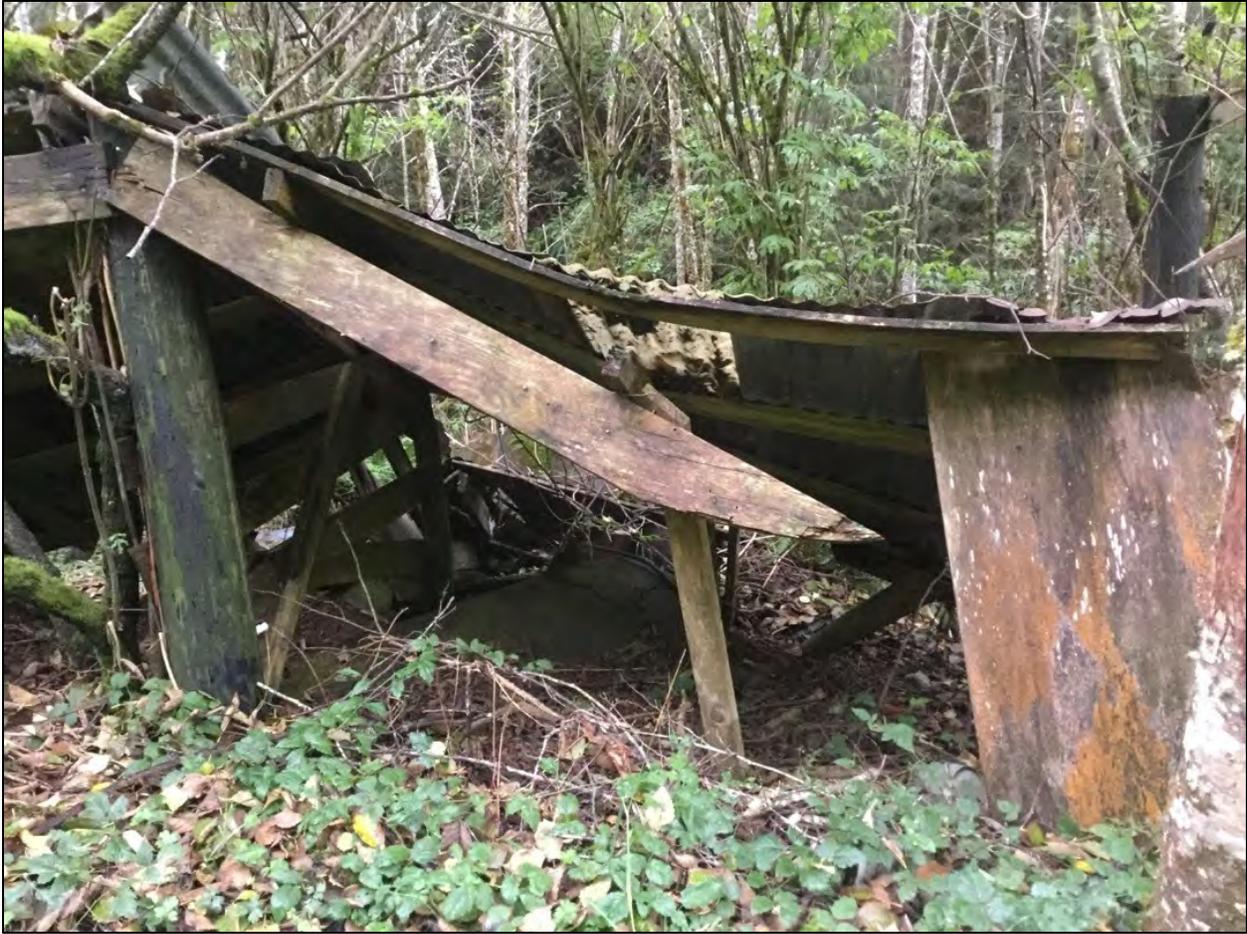
Disused modern agricultural sheds and outbuildings are found at the edges of the meadows. The current landowner acquired the lands near the turn of the 21st century and has not maintained the farm buildings, rather they use the property as hunting lands. No large barns are present. Rather the structures appear to have been shelters for livestock. They are made using modern materials, such as galvanized roofing with fiberglass inserts (Figure 33). The construction materials, milled timbers with galvanized and brass hardware are indeterminate to a specific construction period, but taken together the use of plastic materials and galvanized stamped brackets suggests the structures were constructed in the latter 20th century. Additionally, the refuse piles associated with the ruins and materials within the structures themselves all indicate that the period of use was the last quarter of the 20th century. Plastic paint buckets, water troughs, and modern refuse such as plastic toys and kiddie pools all appear to date to the 1980s-1990s. Furthermore, the materials found adjacent to the buildings and in the creek channels are also from the modern age. One large pile of gallon-wine jugs was identified consisting of a single type of vessel, with no other materials present (Figure 34). Neither the refuse piles or the structures show evidence of historic period use. There are no additions to the shelters, and there does not appear to be multiple phases of deposition within the refuse piles. The ruins represent a late 20th century agricultural property, and are not considered to be historic aged structures, or archaeological sites.

Figure 33
Partially collapsed modern livestock shelter in Area Five
