NEWPORT BIG CREEK DAMS

City Council Work Session 07-20-2015

Engineering Evaluation & Corrective Action Alternatives

Verena Winter, P.E. HDR Engineering

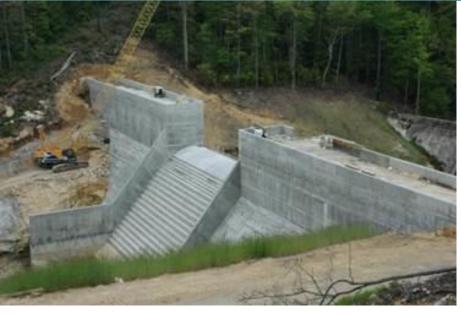
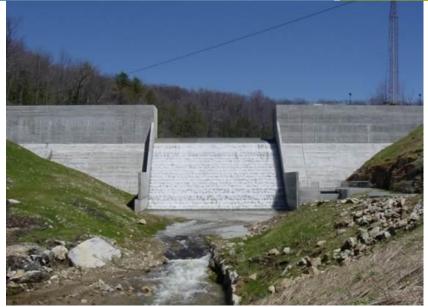
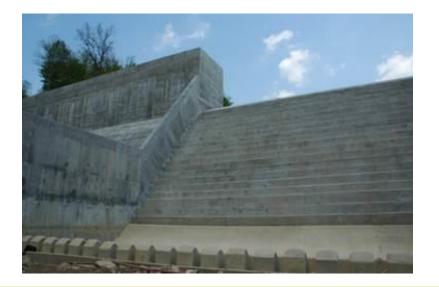
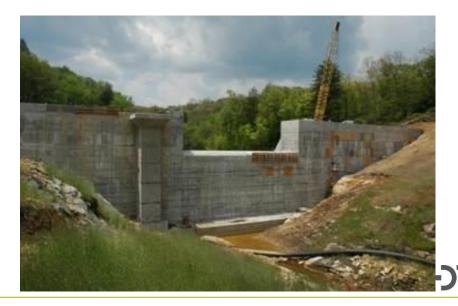
Alternative 2 RCC Dam - Section B-B 2+40 Station (feet)

- Total height = 100 ft at elevation 120 ft
- New water surface elevation = elevation 112 ft
- Excavation to bedrock for new foundation soil

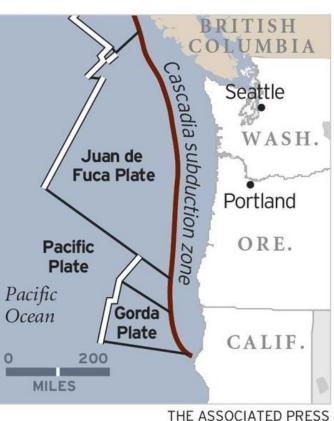
Principal Seismic Sources in Oregon

- Cascadia Subduction Zone (CSZ)
- Crustal Faults
