Seismic Evaluation of Big Creek Dams No. 1 and 2

Phase 3 – Engineering Evaluation and Corrective Action Alternatives
Newport Big Creek Dams

Newport, Oregon

June 30, 2015

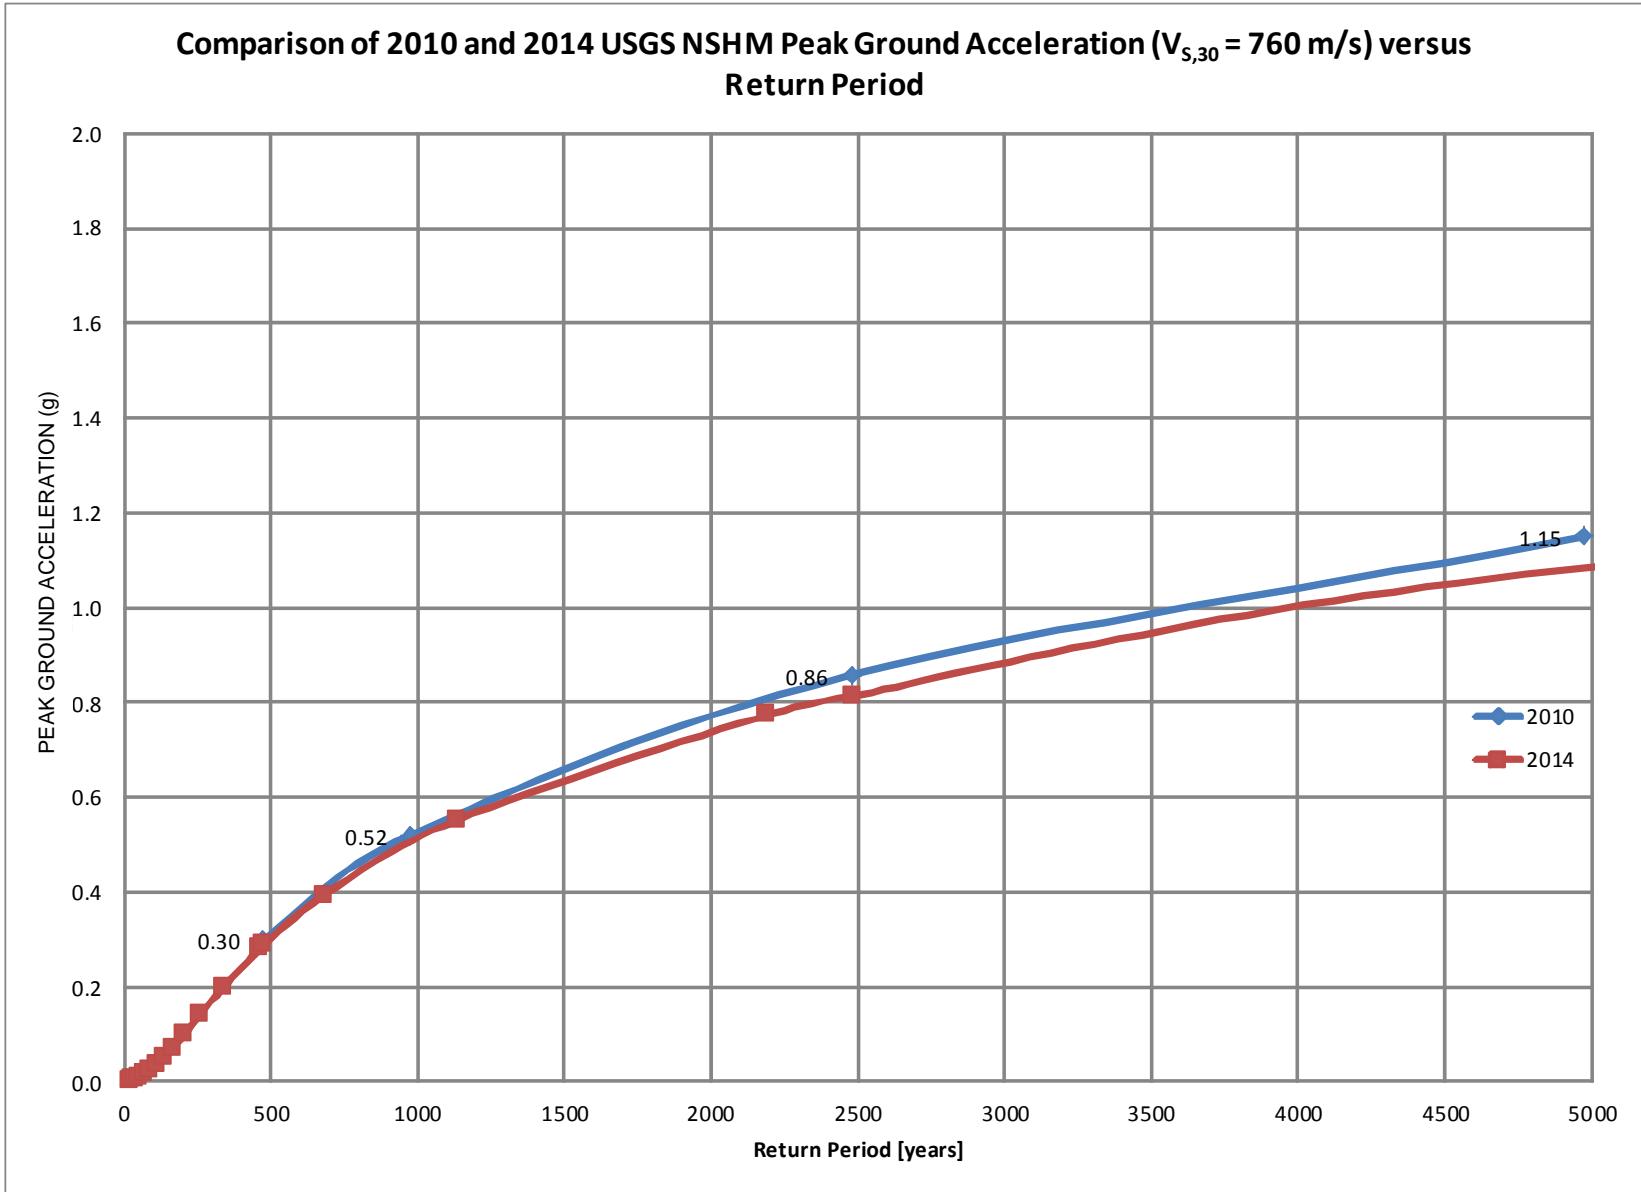
FIG. 1

NATIONAL SEISMIC HAZARD MAP
 PGA COMPARISON

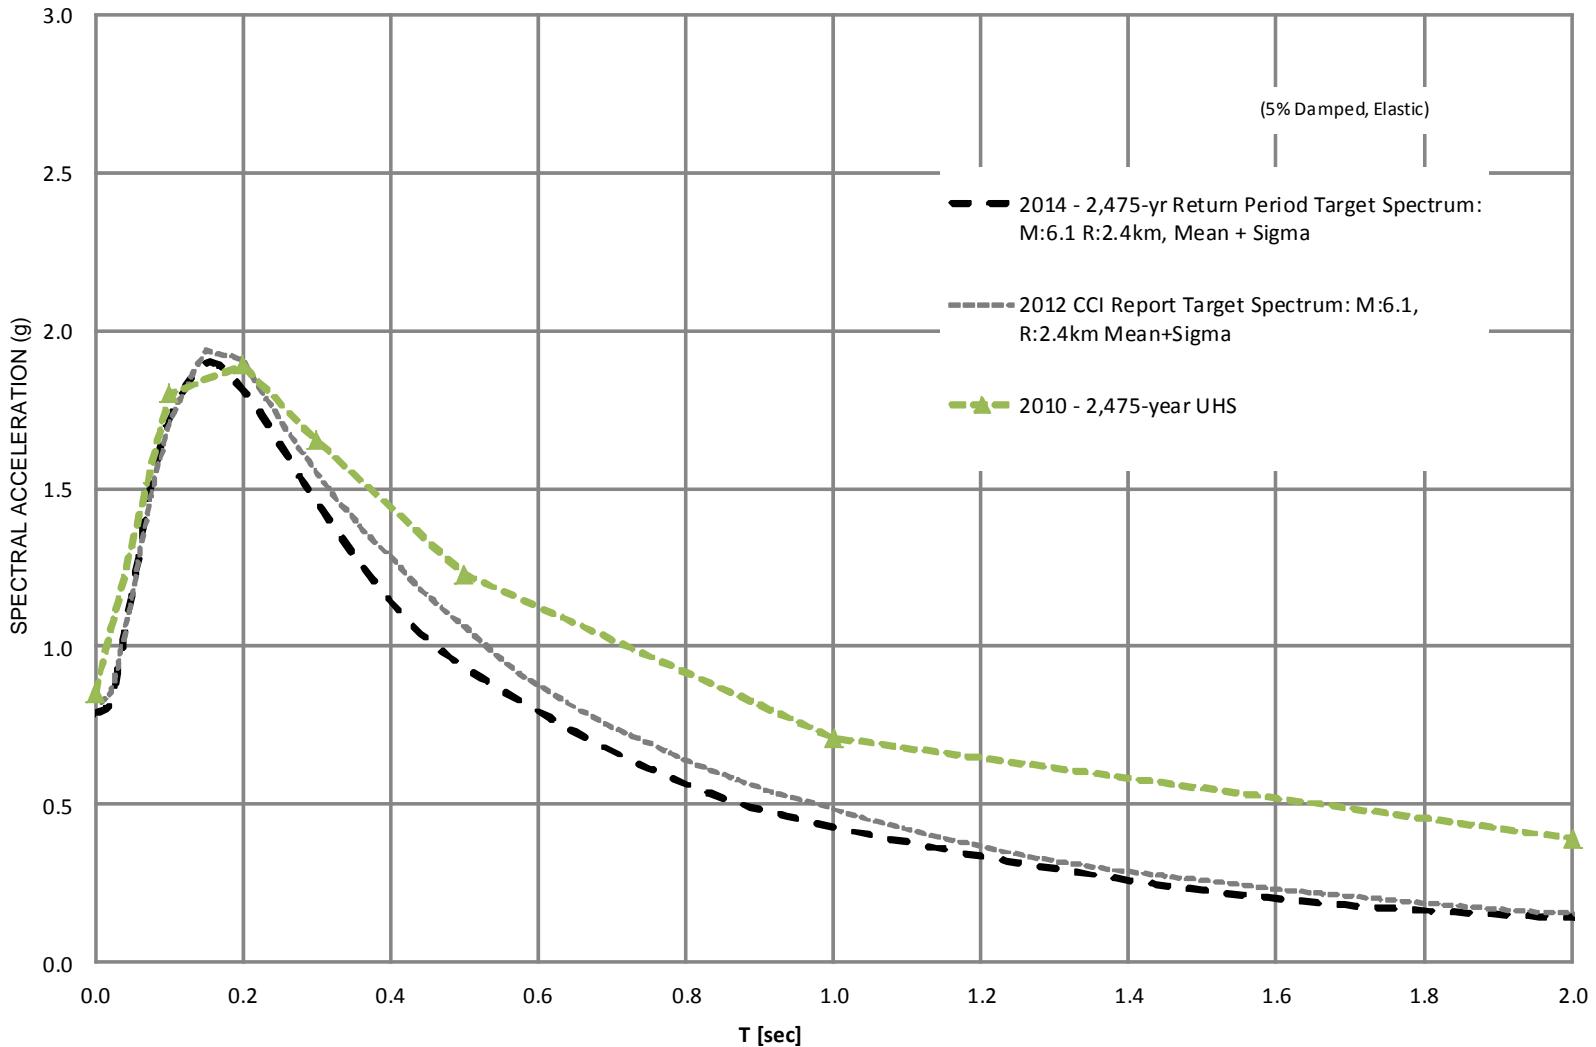
Comparison of New Target Spectrum and Previous Target Spectrum for Crustal Source with USGS NSHM Uniform Hazard Response Spectra for Reference

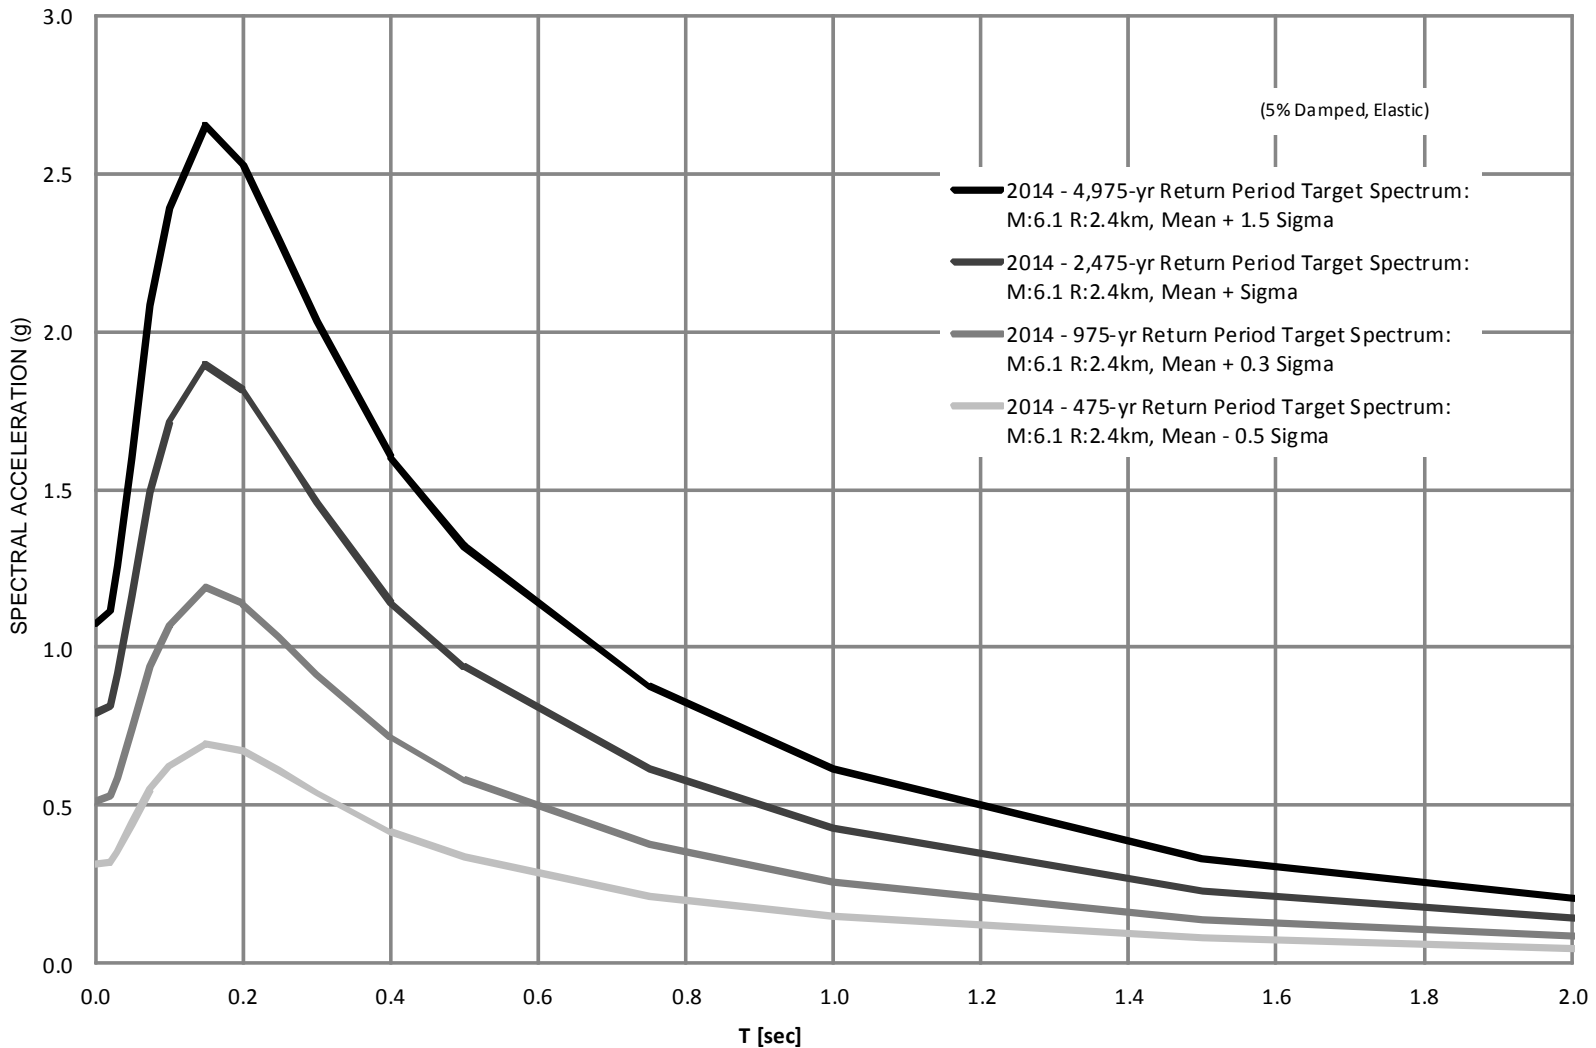
Crustal Source - Target Response Spectra For Return Periods of 475-yr, 975-yr, 2,475-yr and 4,975-yr

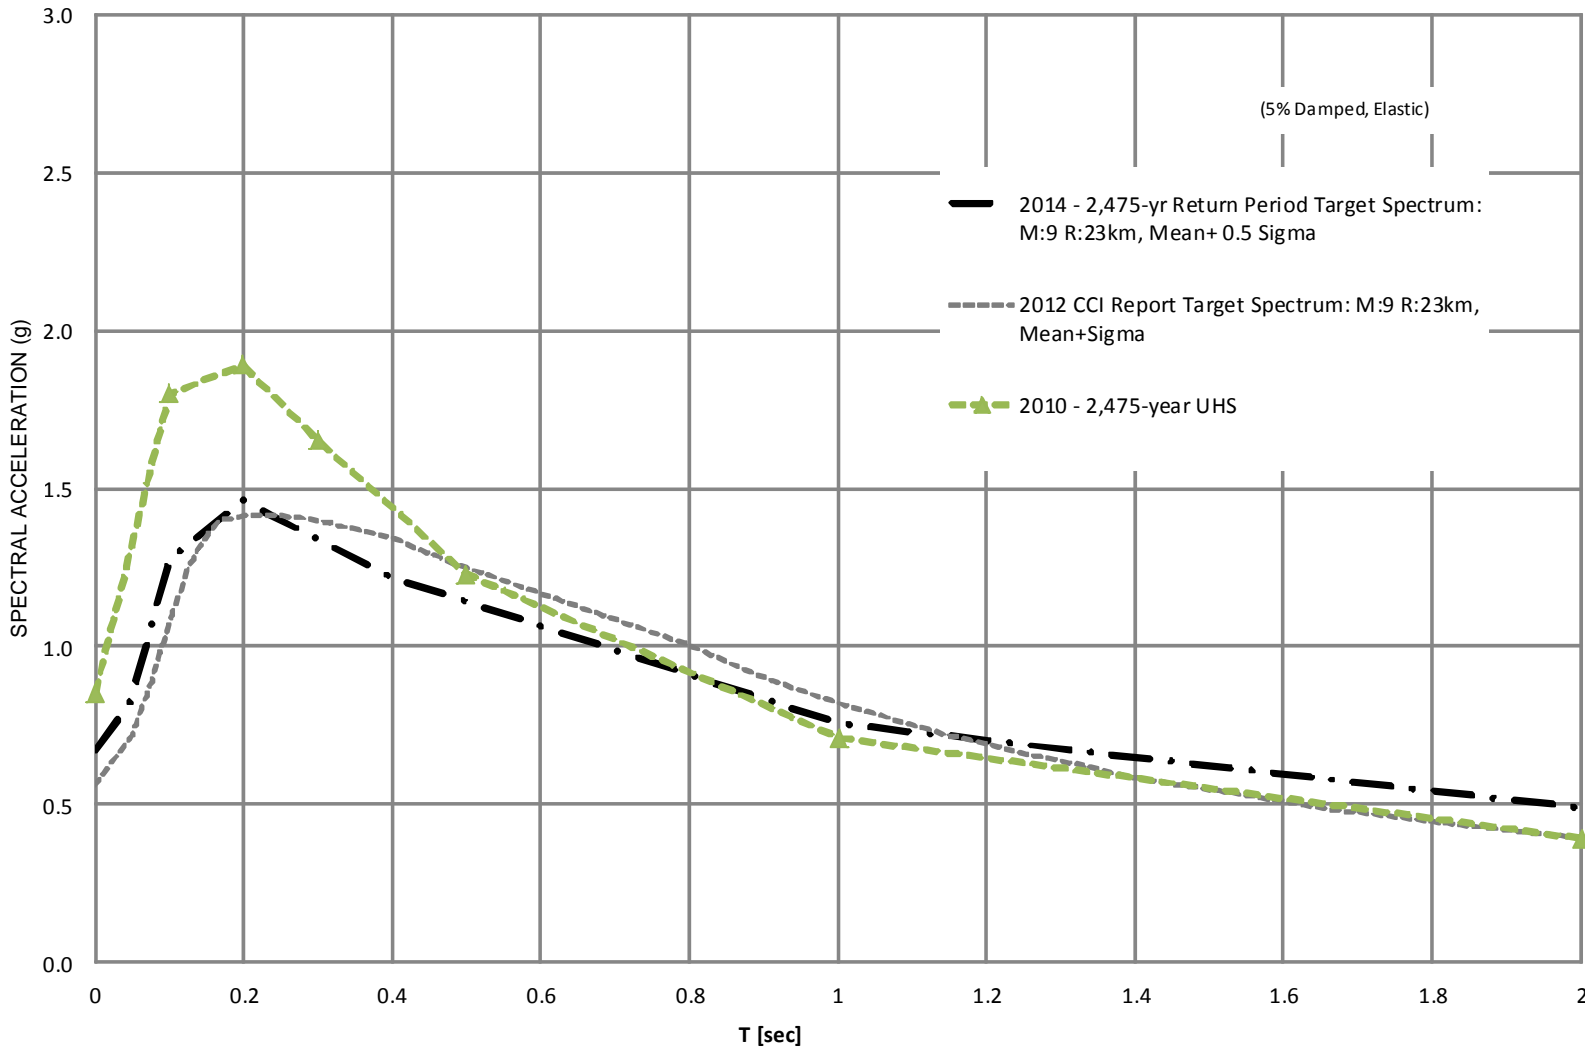
Comparison of New Target Spectrum and Previous Target Spectrum for CSZ Interface Source with USGS NSHM Uniform Hazard Response Spectra for Reference

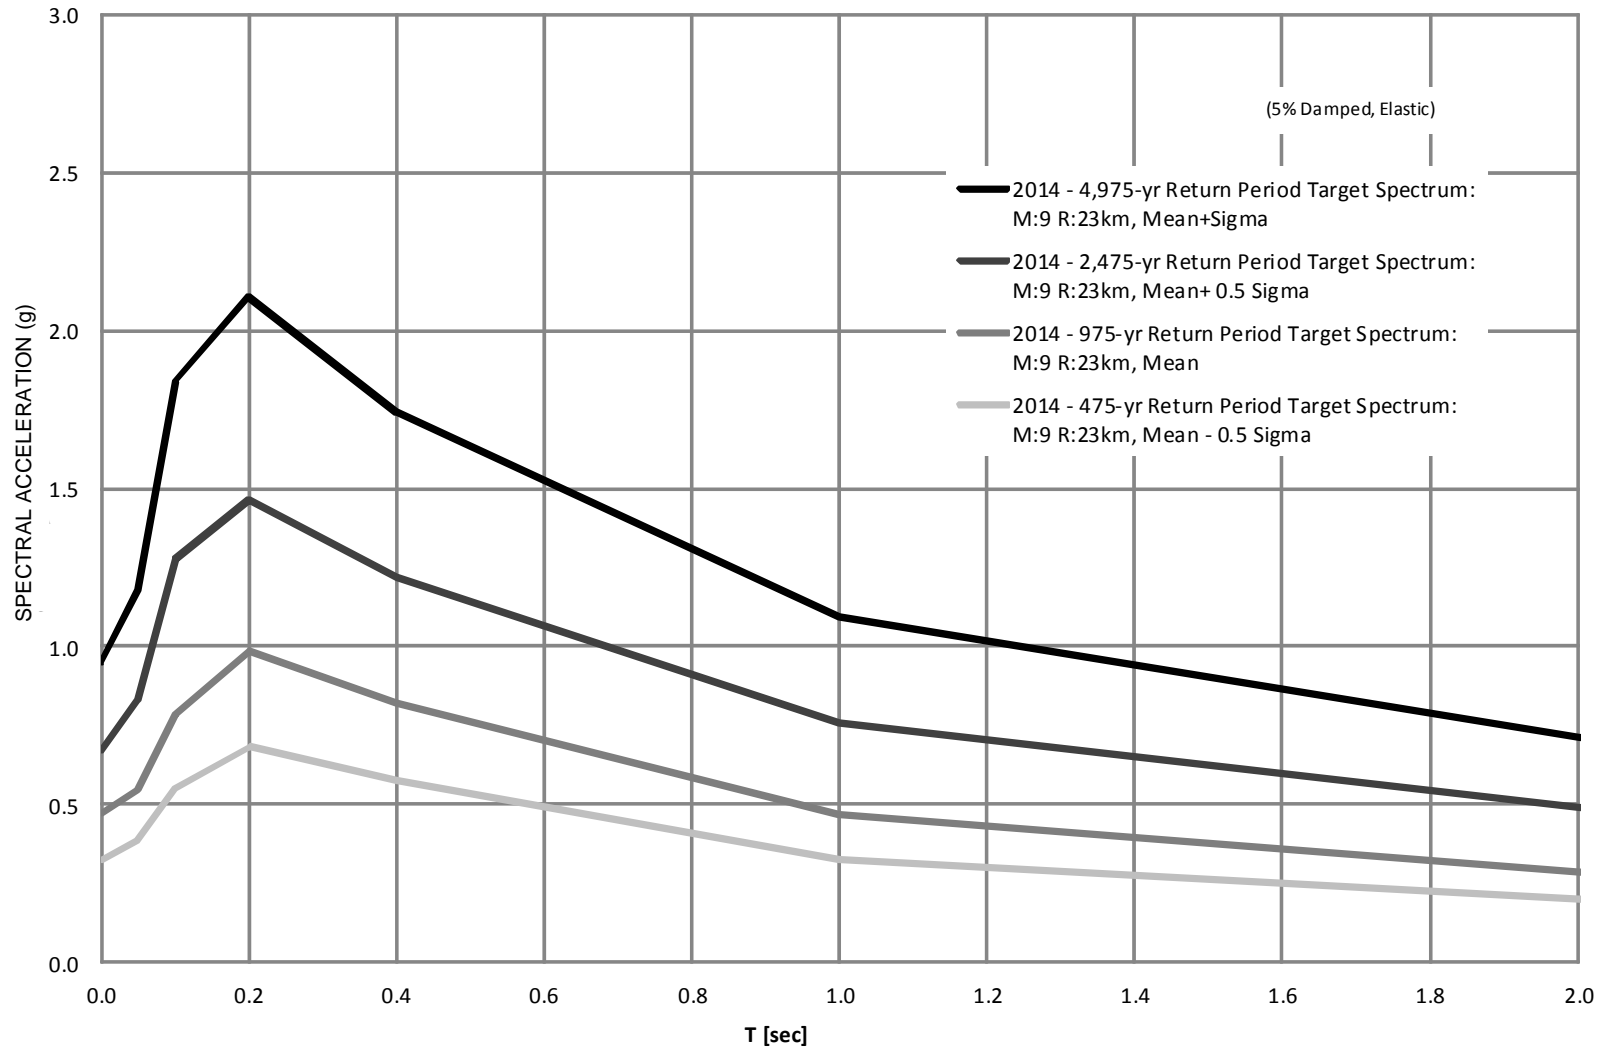
Cascadia Subduction Zone Interface Source - Target Response Spectra For Return Periods of 475-yr, 975-yr, 2,475-yr and 4,975-yr

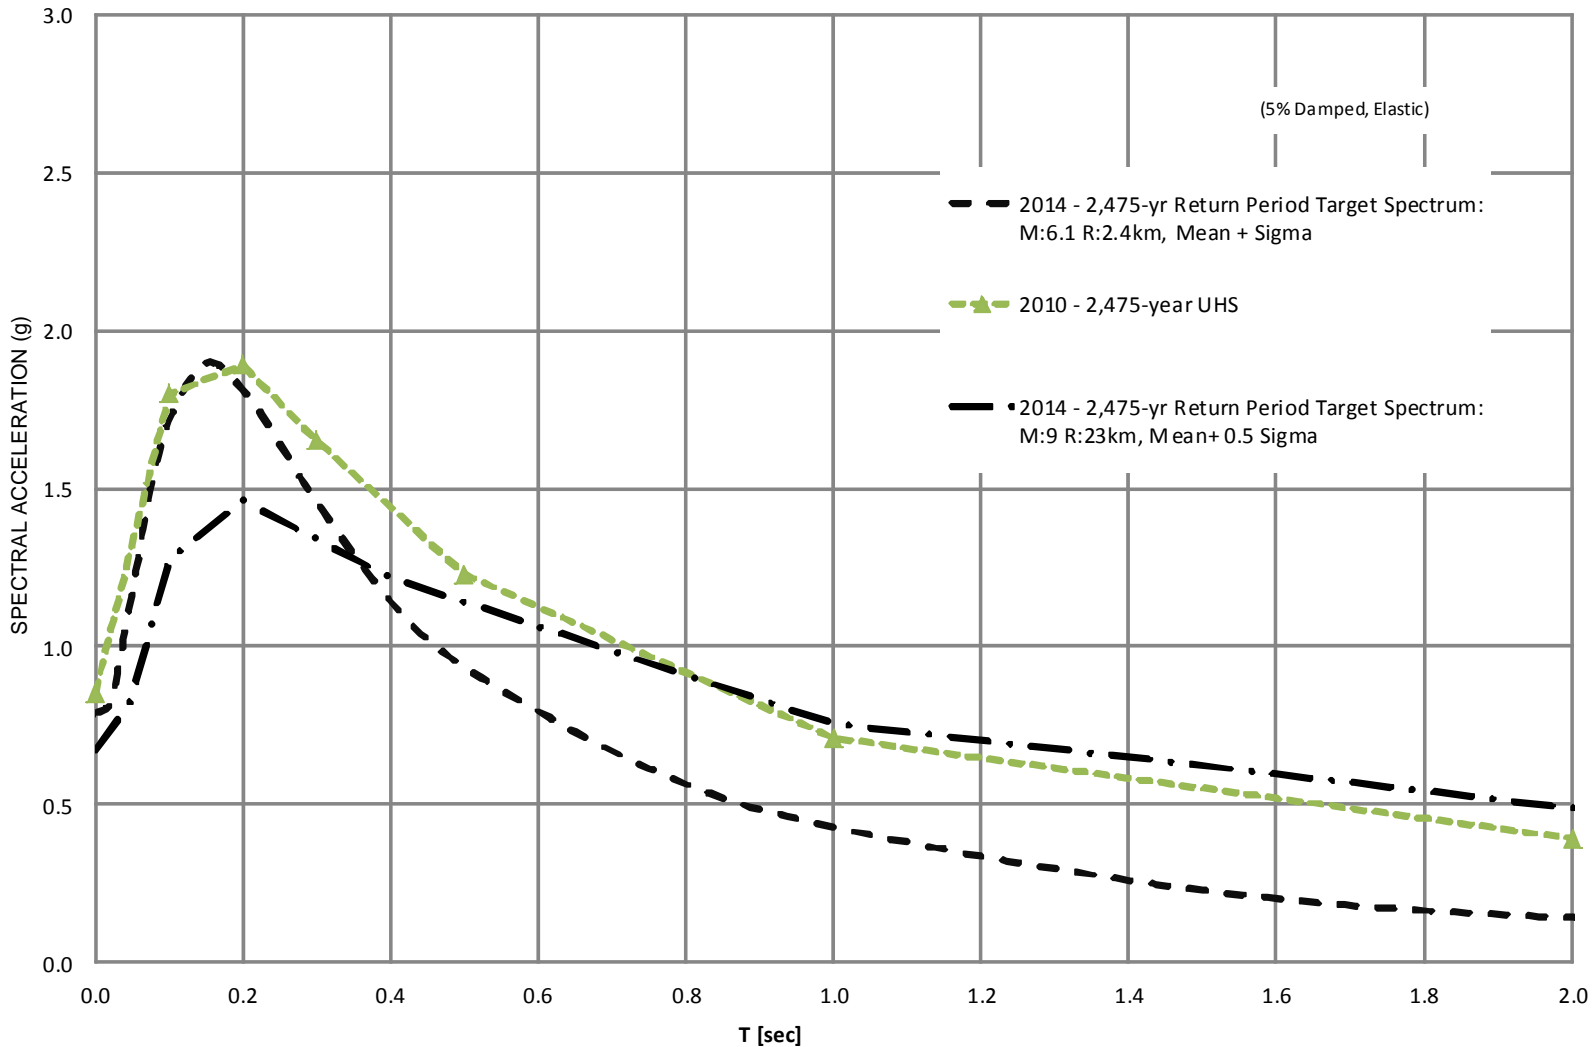
Comparison of Target Spectra and 2010 USGS NSHM Uniform Hazard Response Spectrum for 2,475-year Mean Return Period

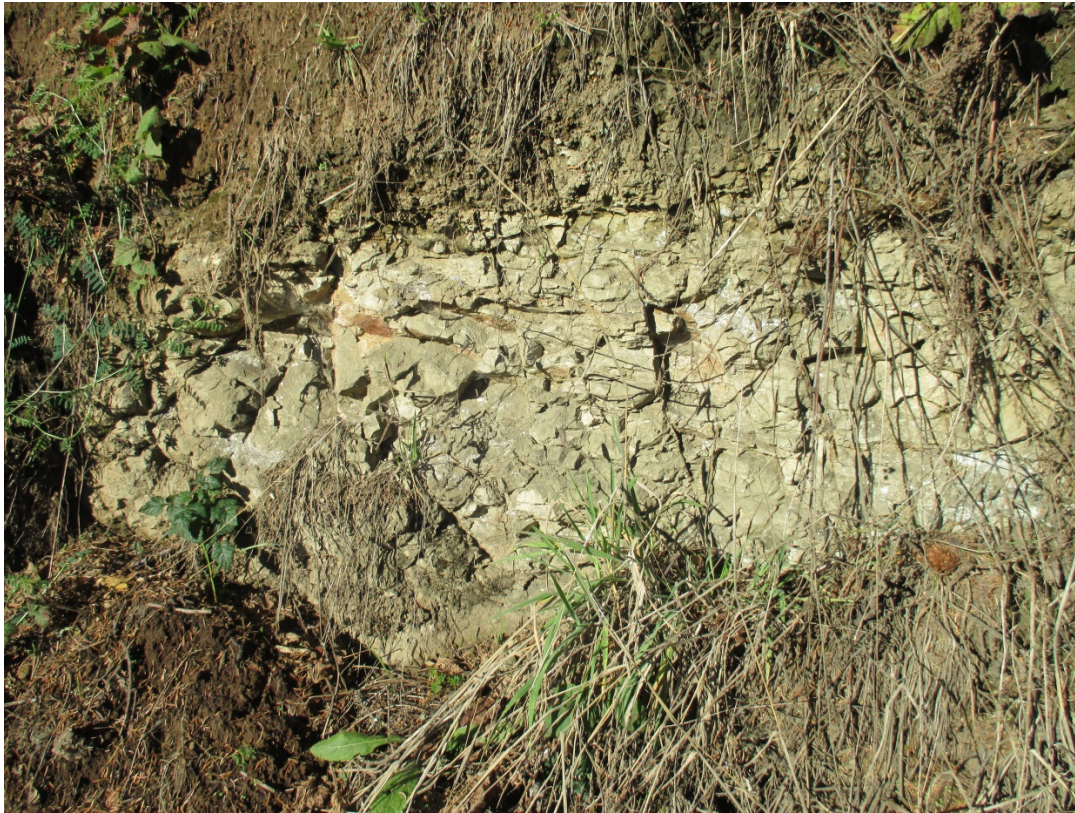
Photo 1: Nye Formation Siltstone in right abutment of BC 1.

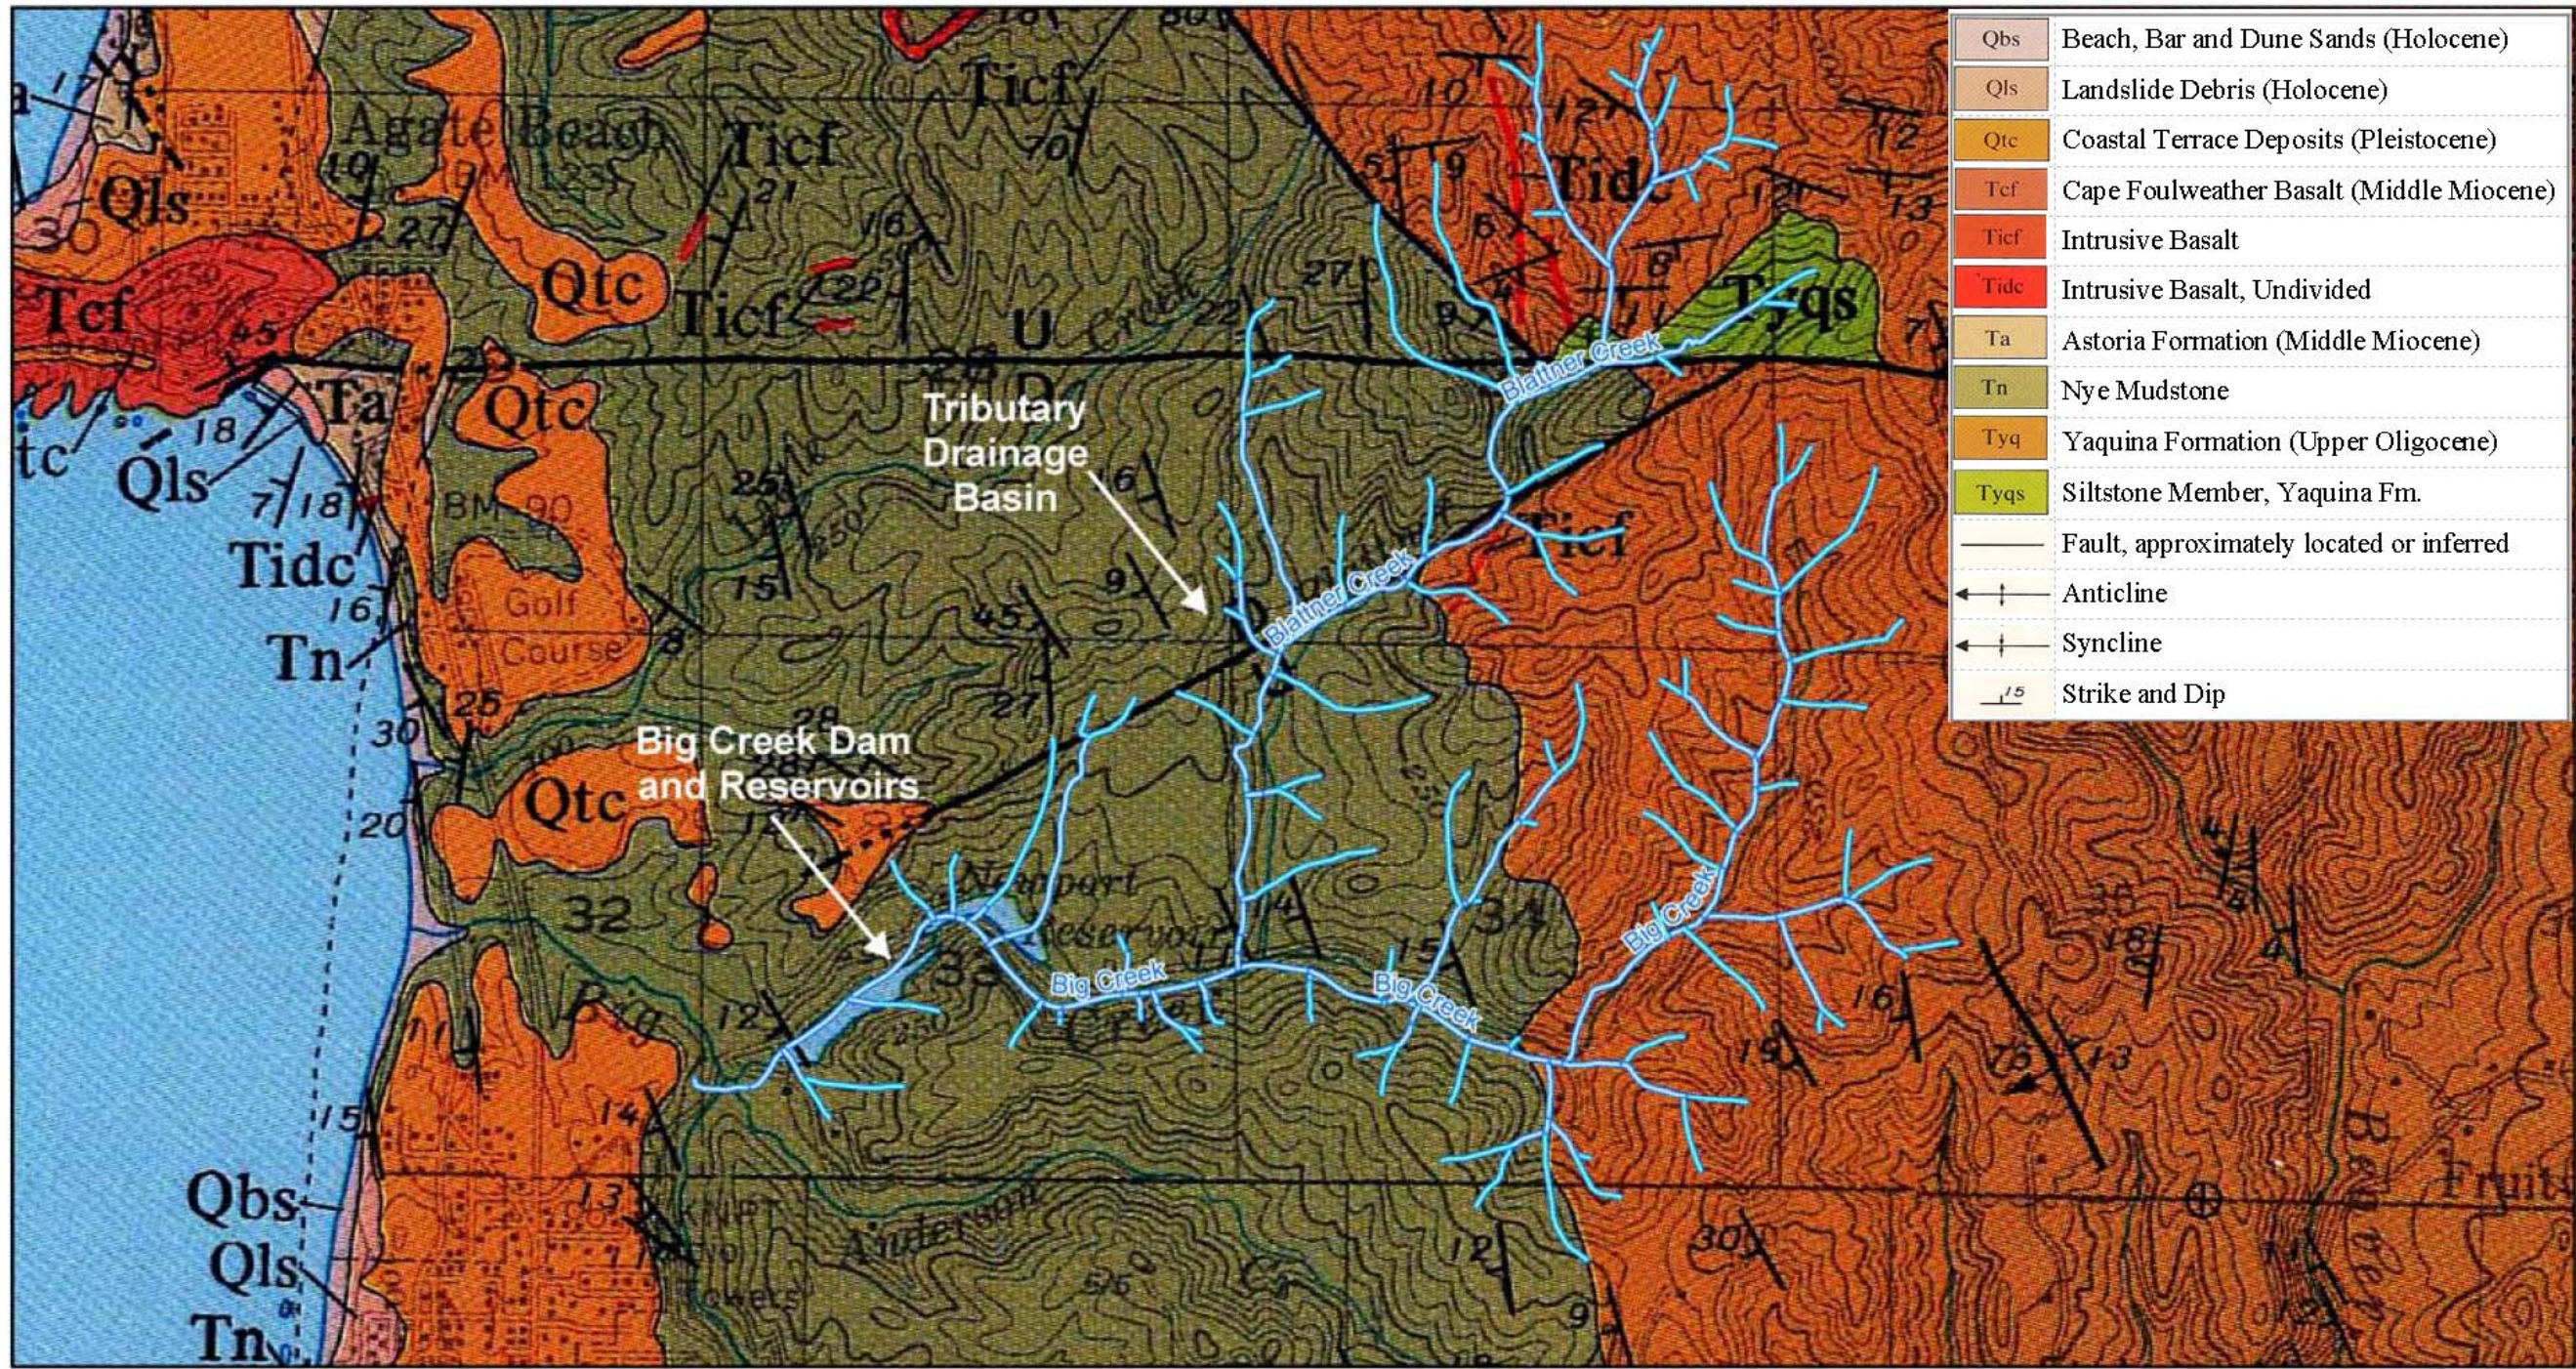
Figure B-4. Big Creek Subsurface Profile

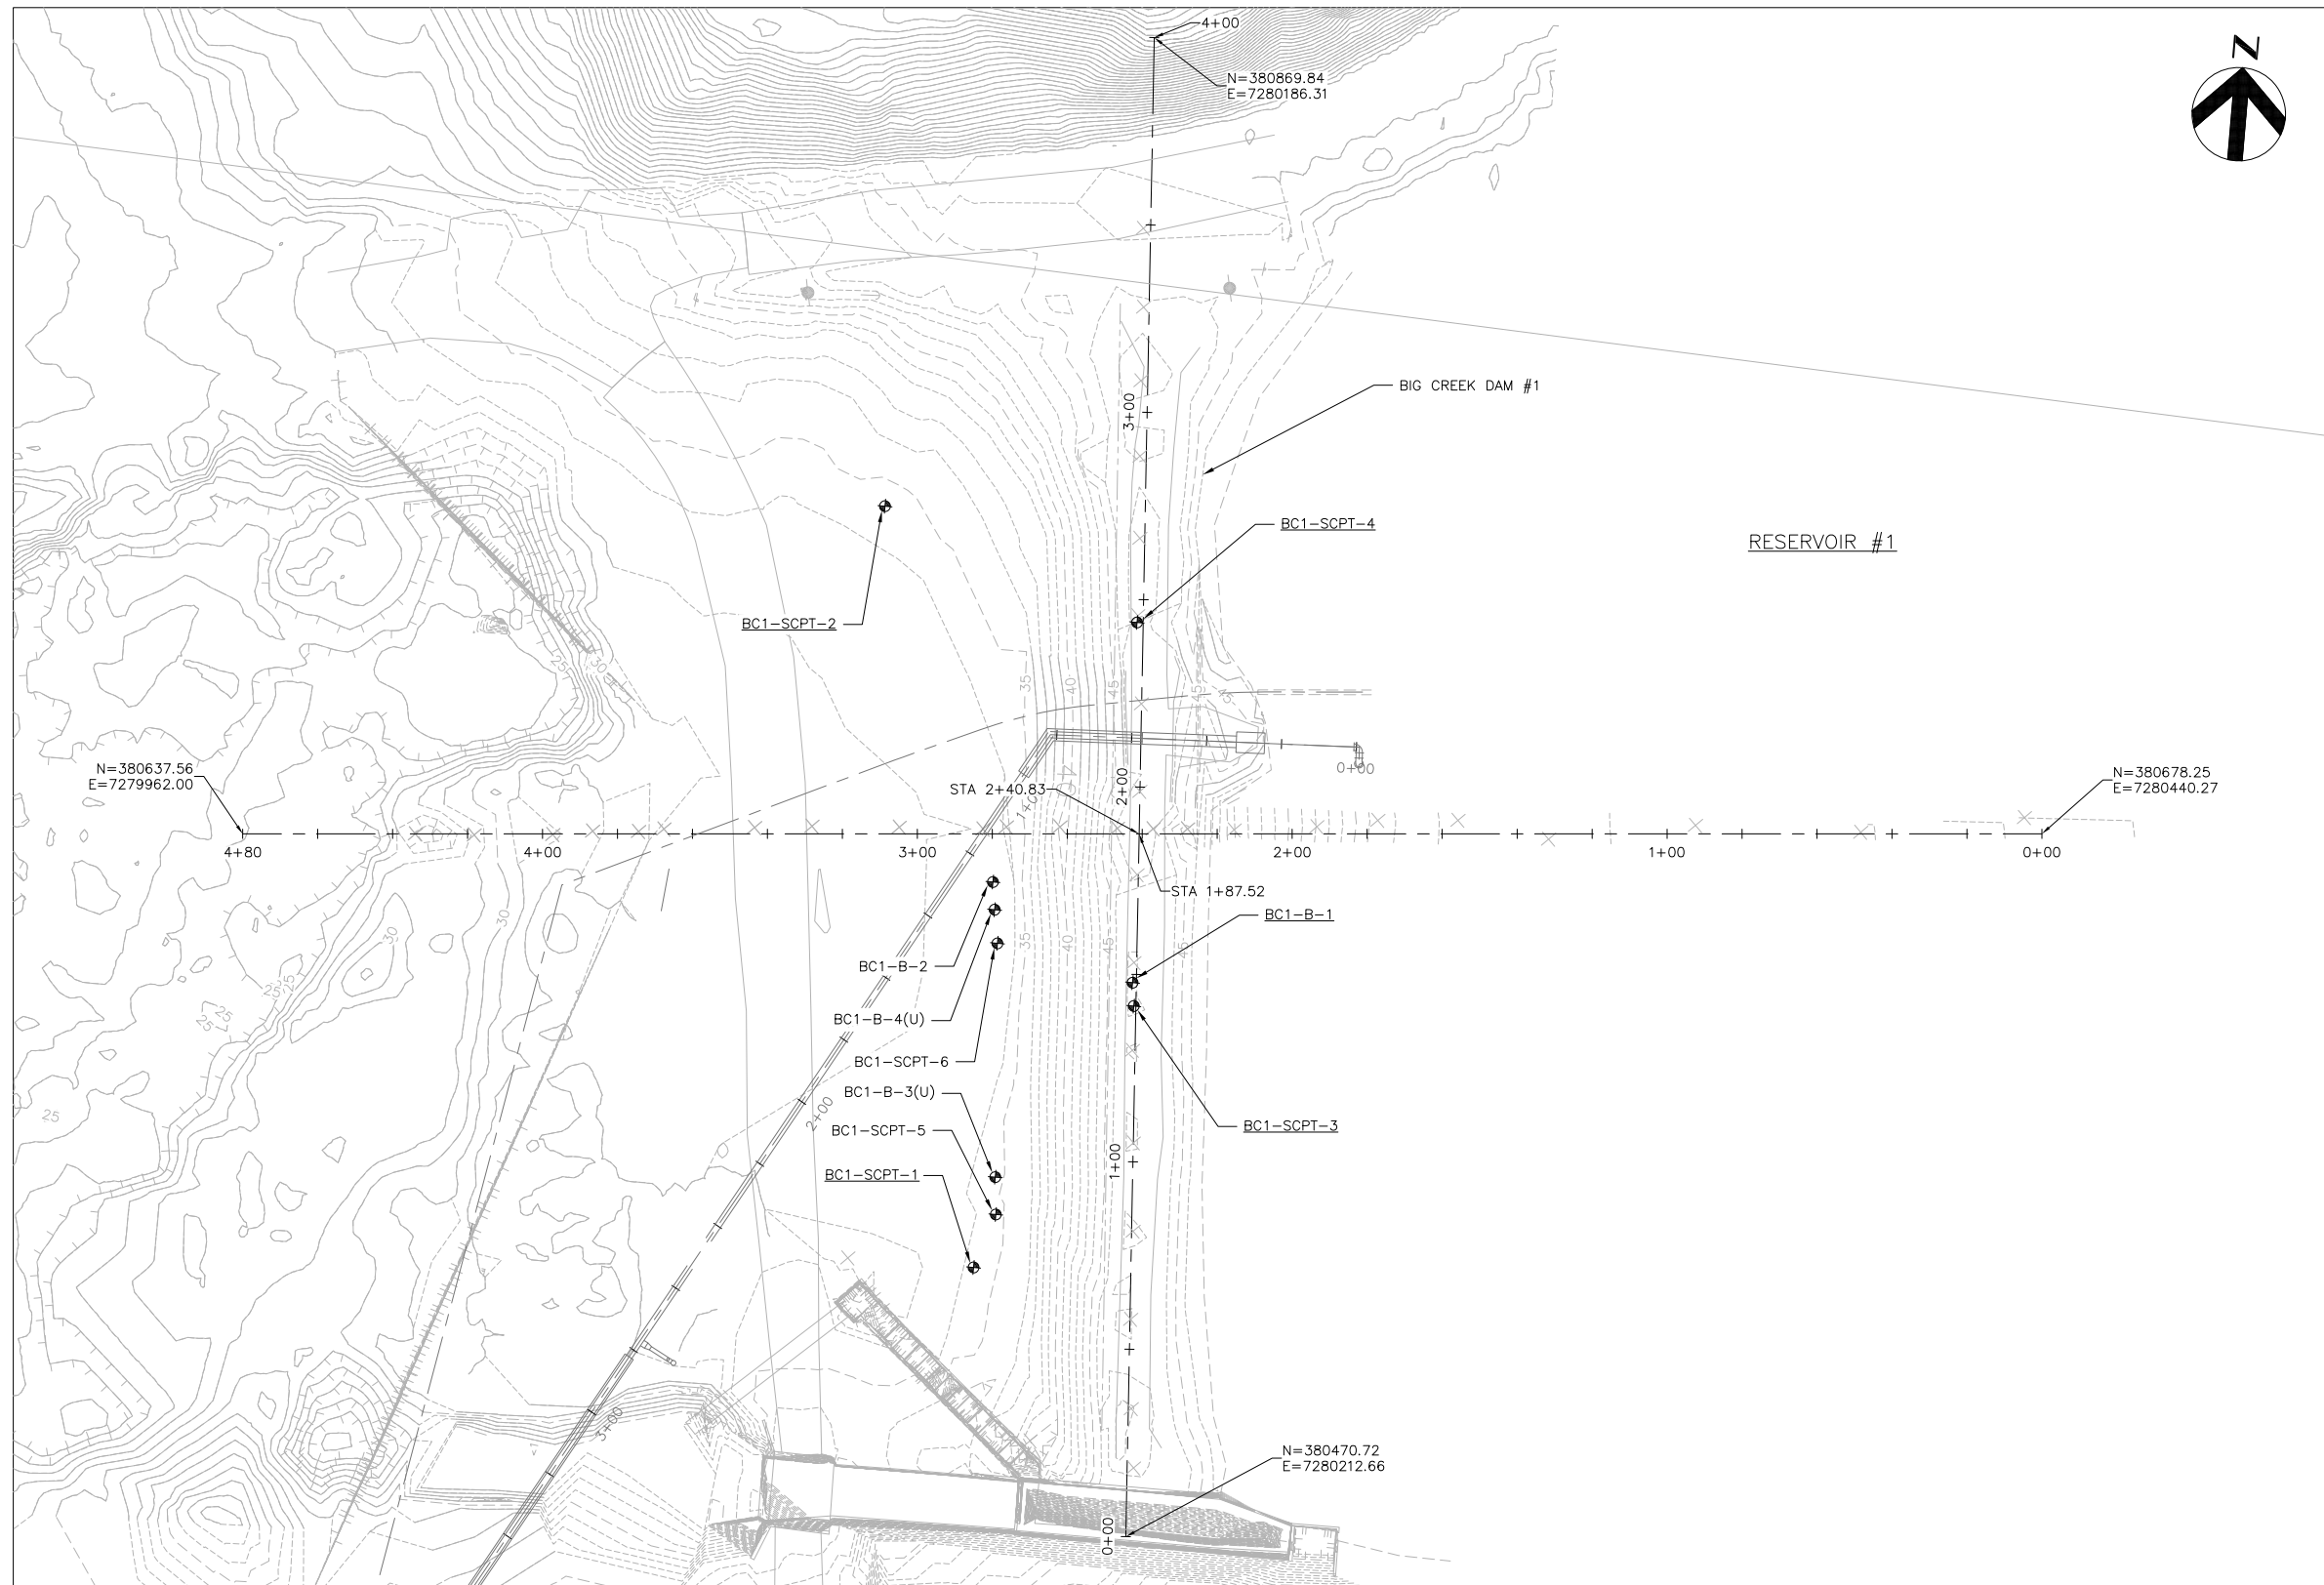
CITY OF NEWPORT OREGON SEISMIC EVALUATION OF BIG CREEK DAMS #1 & 2	DATE June 2015
	DAM BC1 - SITE EXPLORATION LOCATION PLAN	FIGURE B-1

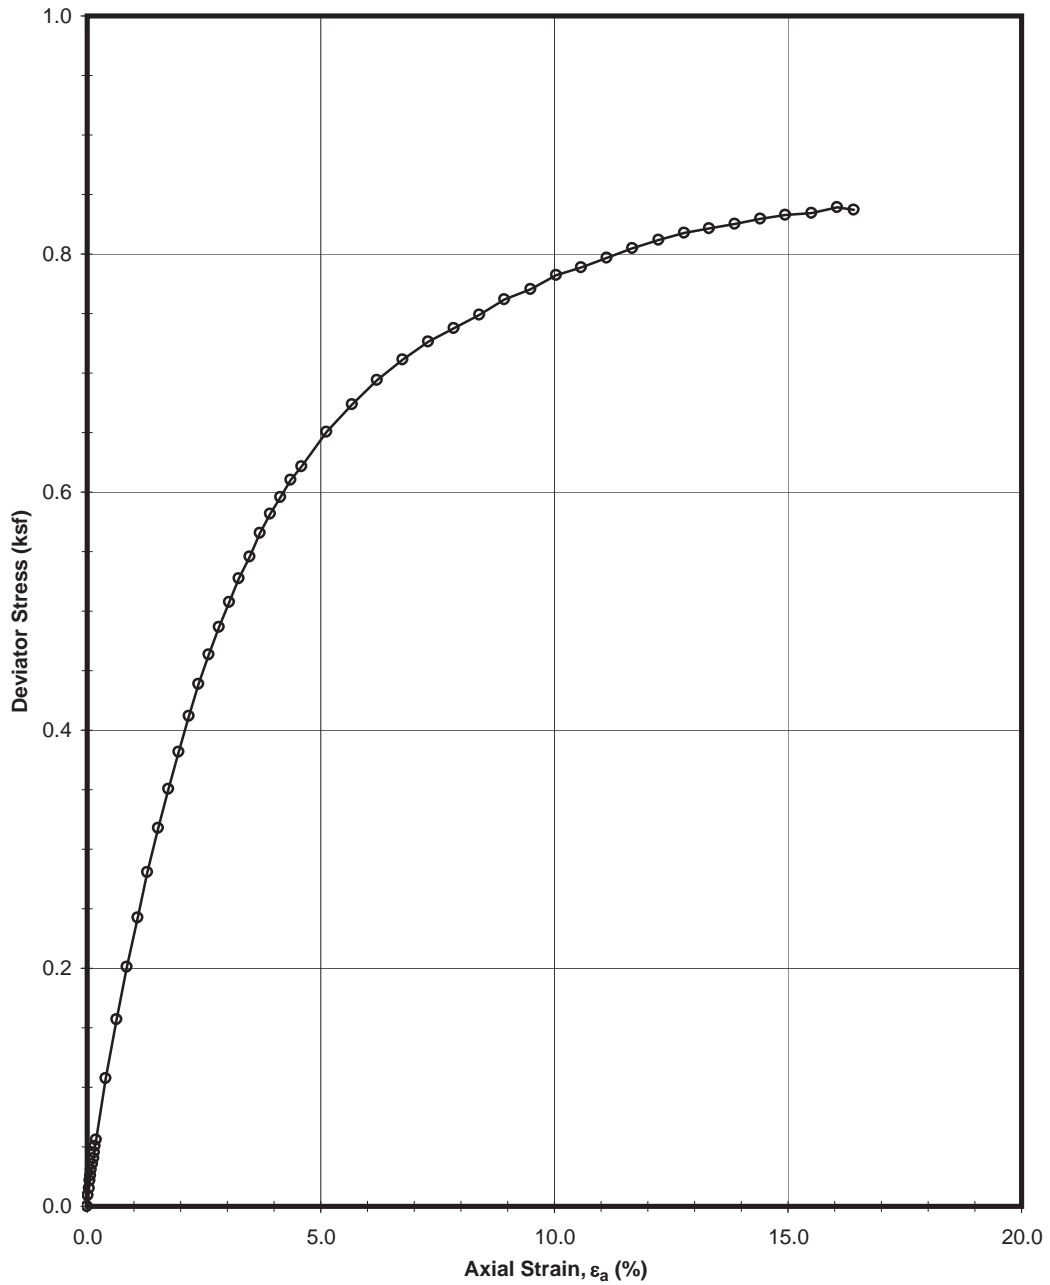
**Unconsolidated-Undrained Triaxial Compression Test
Intact Specimen**

Boring BH-1 BC#1, Sample SH-1-8, Depth 31.05 ft
Confining Pressure = 15.3 psi
Big Creek Dam #1 and Big Creek Dam #2

One unconsolidated-undrained triaxial test assignment was not performed because the sample was in an untestable condition. Plate 4-3 displays a photo of the untestable sample.

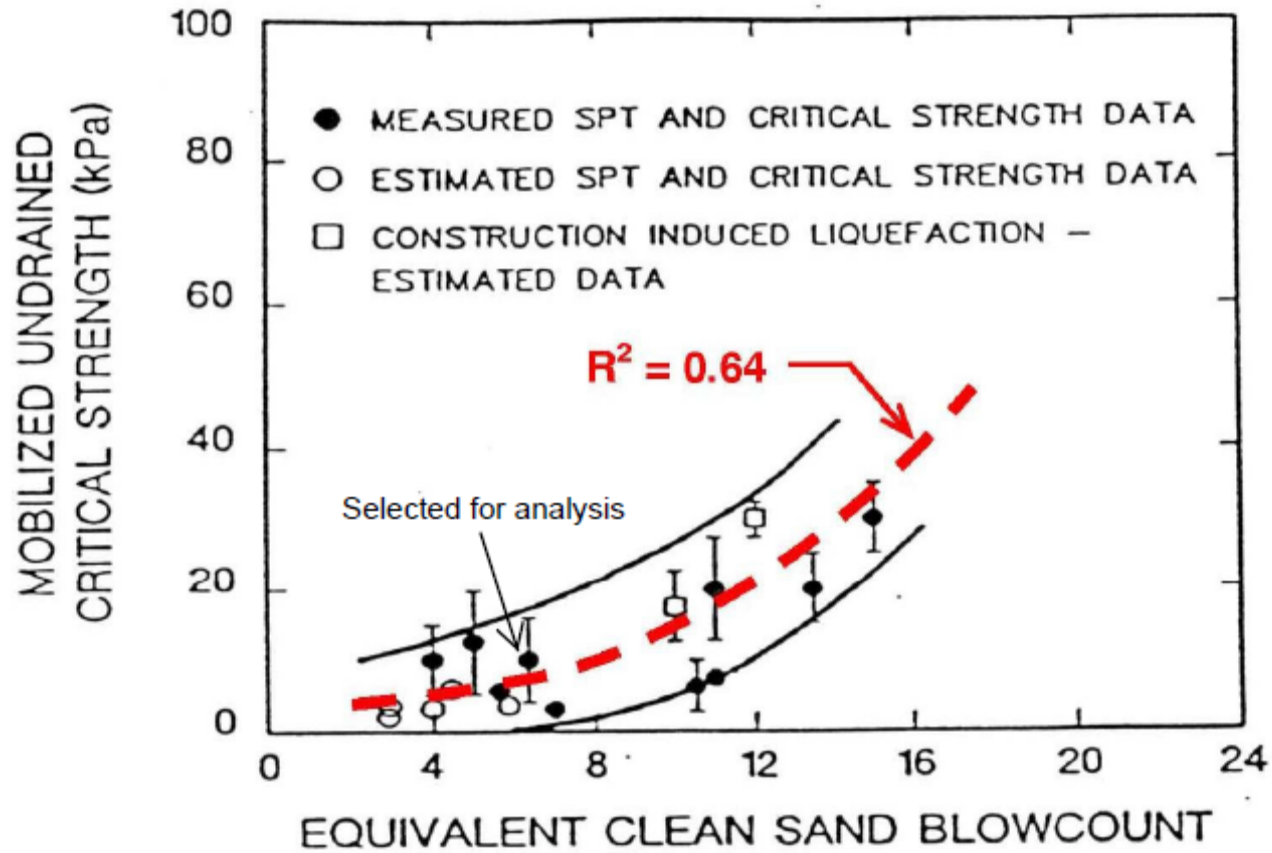
Figure 4-14: Regression of the Full-Scale Field Failure Case History Data of Seed and Harder (1990) Plotted in the Critical State Context as $S_{u,r}$ vs. $N_{1,60,CS}$.

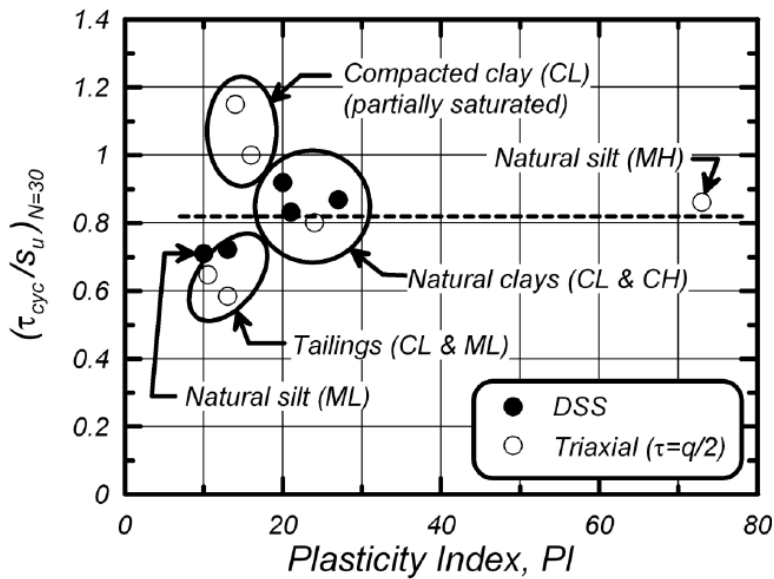
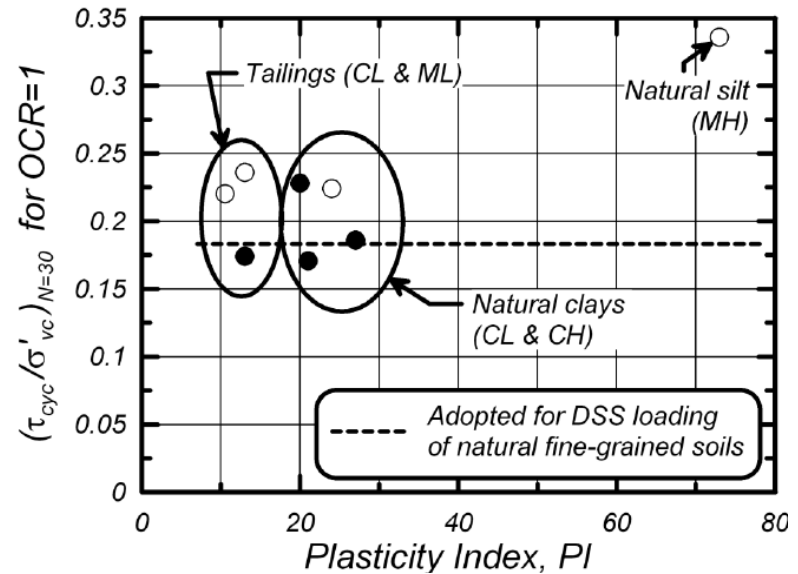
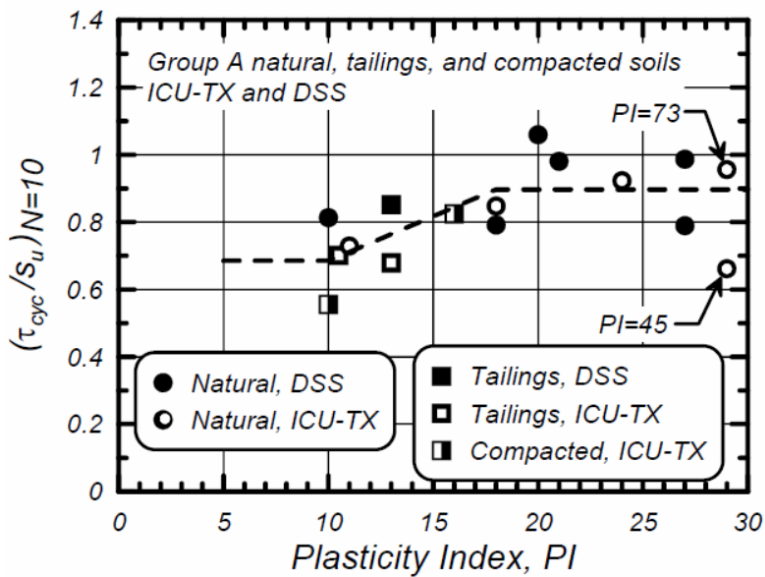
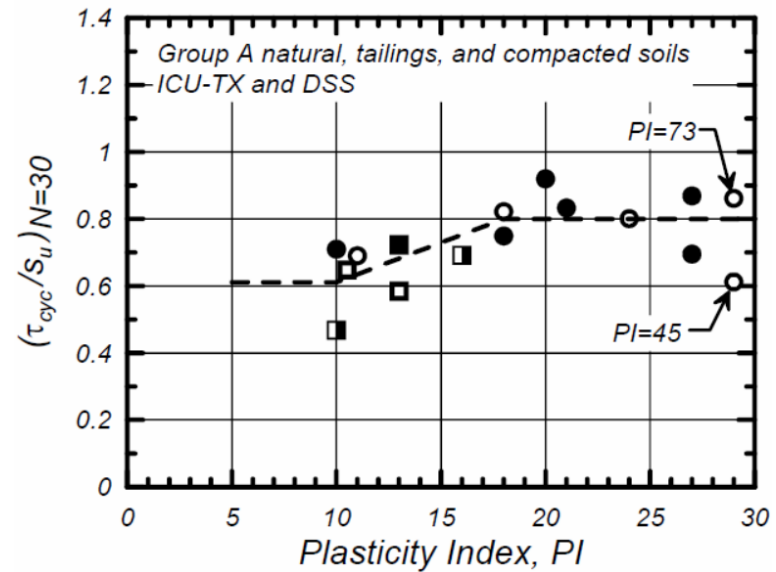
PROJECT NO.	101492	Shear Strength Reduction Based on Plasticity Index		FIGURE
DRAWN:	<drawn>			
DRAWN BY:	<drawn by>	BIG CREEK DAMS 1 AND 2 NEWPORT, OREGON		D-1.8
CHECKED BY:	<checked by>			
FILE NAME:	<file name>	ORIGINATOR:	<originated by>	DRAWING CATEGORY: <drawing category>
		APPROVED BY:	<approved by>
