Seismic Evaluation of Big Creek Dams No. 1 and 2

Phase 3 – Engineering Evaluation and Corrective Action Alternatives
Newport Big Creek Dams

Newport, Oregon

June 30, 2015

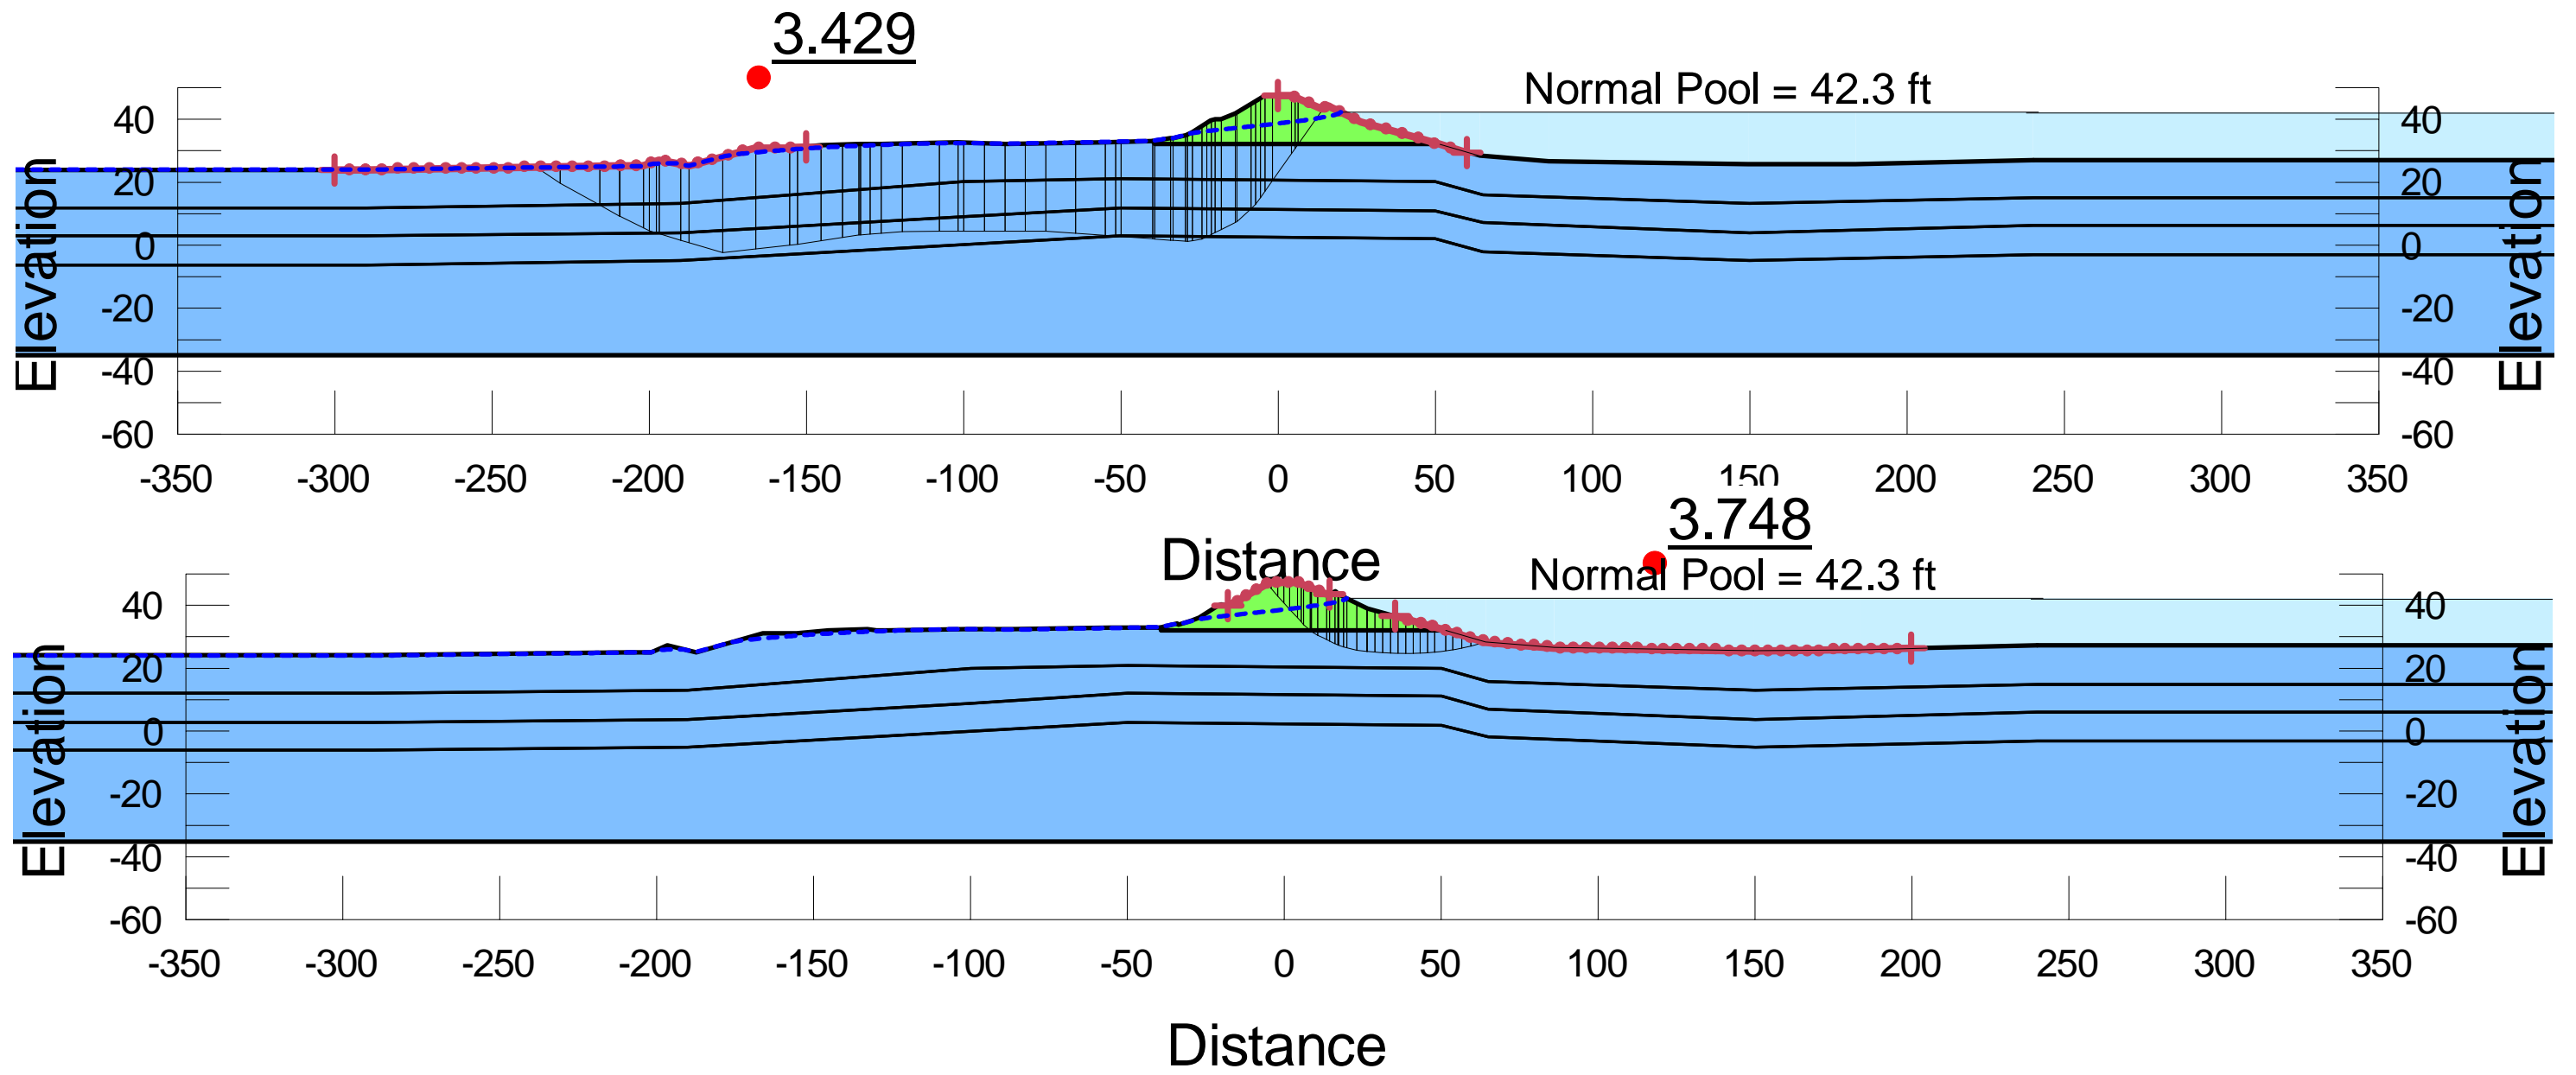
PROJECT NO.	221223	BC -1 Drained Stability Analysis Results		FIGURE
DRAWN:	05/14/15	BIG CREEK DAMS 1 AND 2 NEWPORT, OREGON		
DRAWN BY:	STA			ORIGINATOR:
CHECKED BY:	KAF	STA	<drawing category>	
FILE NAME:	<file name>	APPROVED BY:	VW

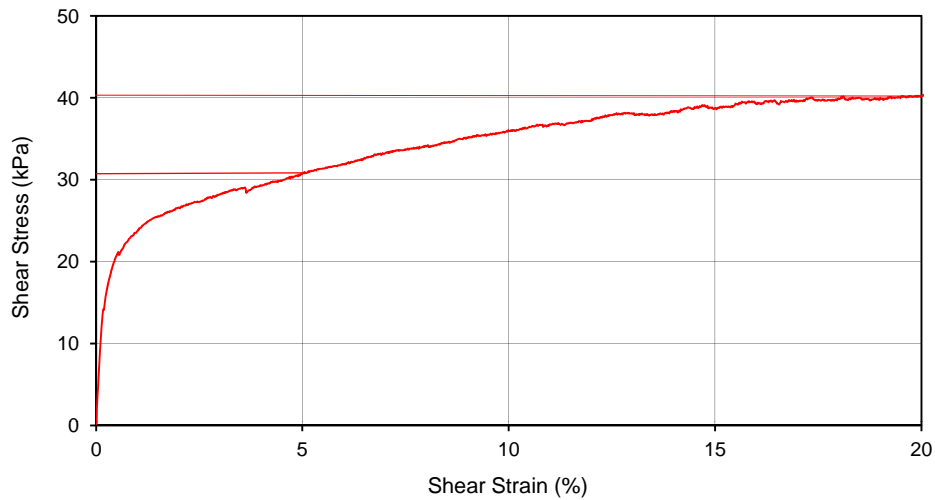
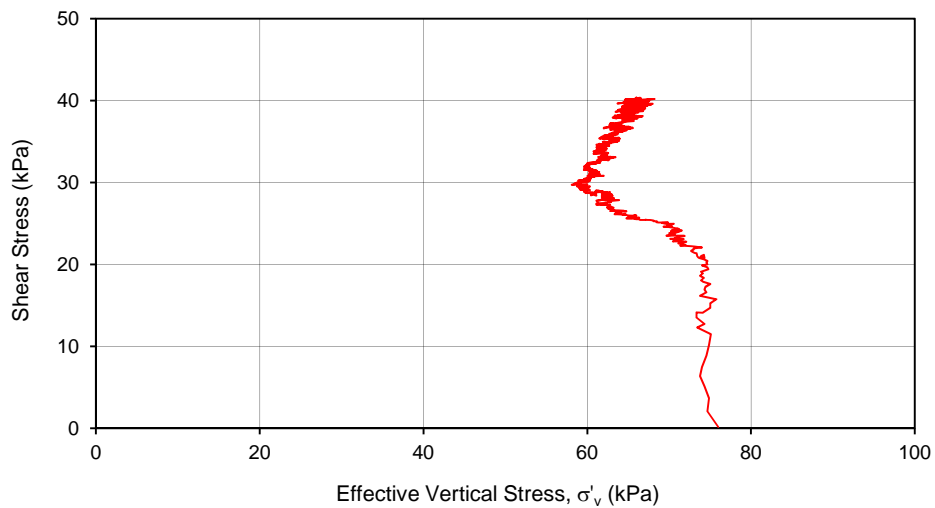
POST-CYCLIC STATIC SHEAR TEST

Note: Test performed after stress-controlled DSS test at average cyclic stress ratio, CSR = 0.15 with 8% excess pore pressure. Post-cyclic tests performed under initial condition of zero shear stress

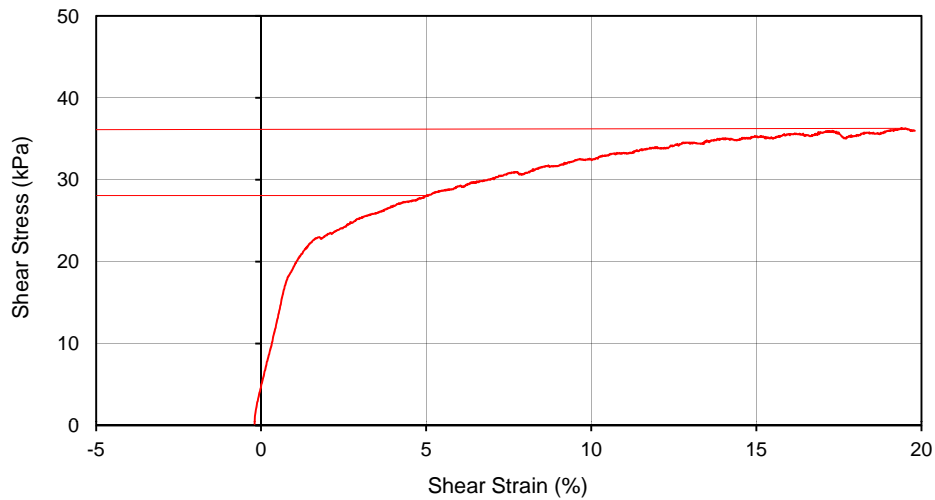
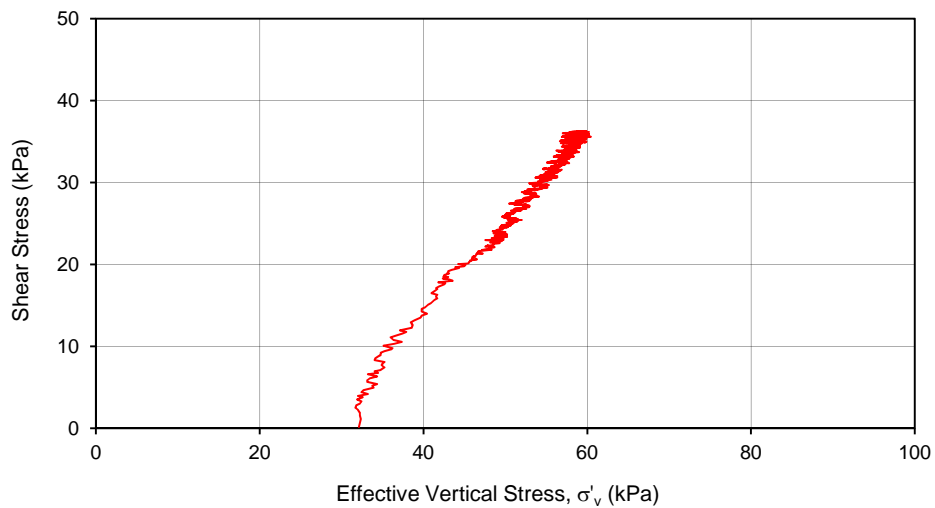
POST-CYCLIC STATIC SHEAR TEST

Note: Test performed after stress-controlled DSS test at average cyclic stress ratio, CSR = 0.25 with 59% excess pore pressure. Post-cyclic tests performed under initial condition of zero shear stress

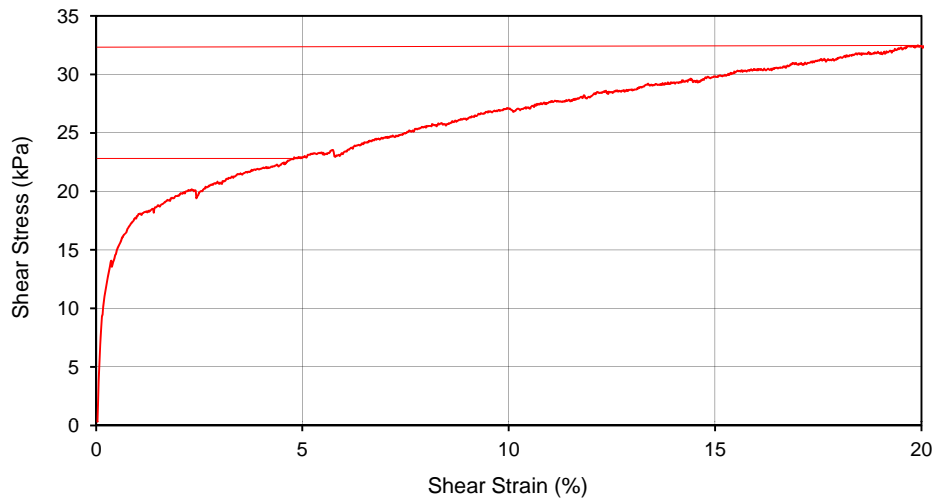
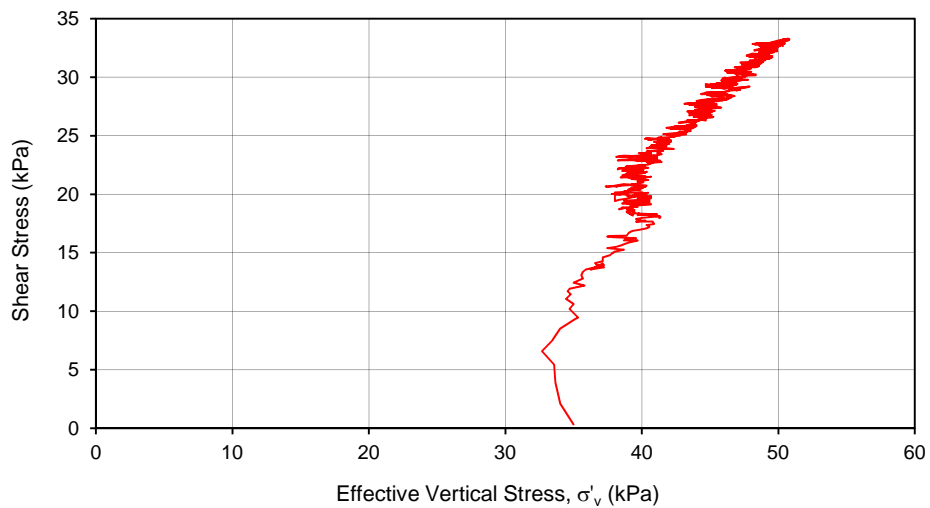
POST-CYCLIC STATIC SHEAR TEST

Note: Test performed after stress-controlled DSS test at average cyclic stress ratio, CSR = 0.15 with 2% excess pore pressure. Post-cyclic tests performed under initial condition of zero shear stress

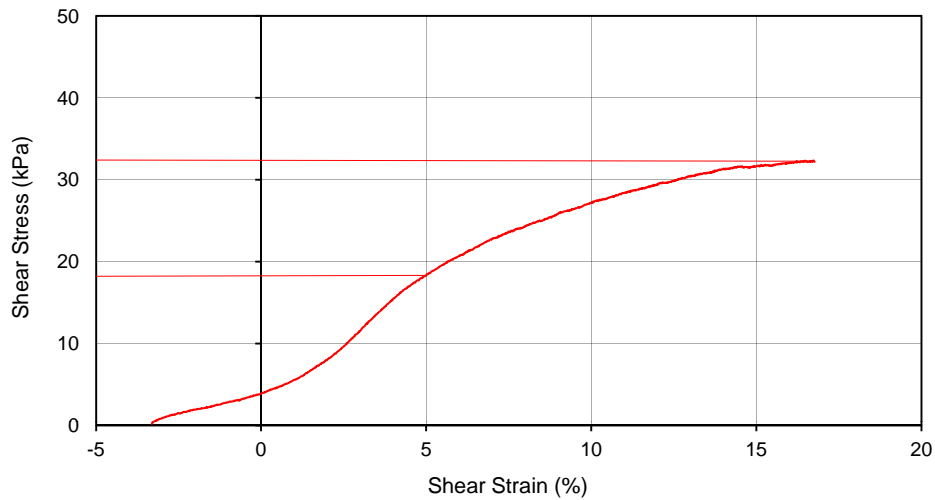
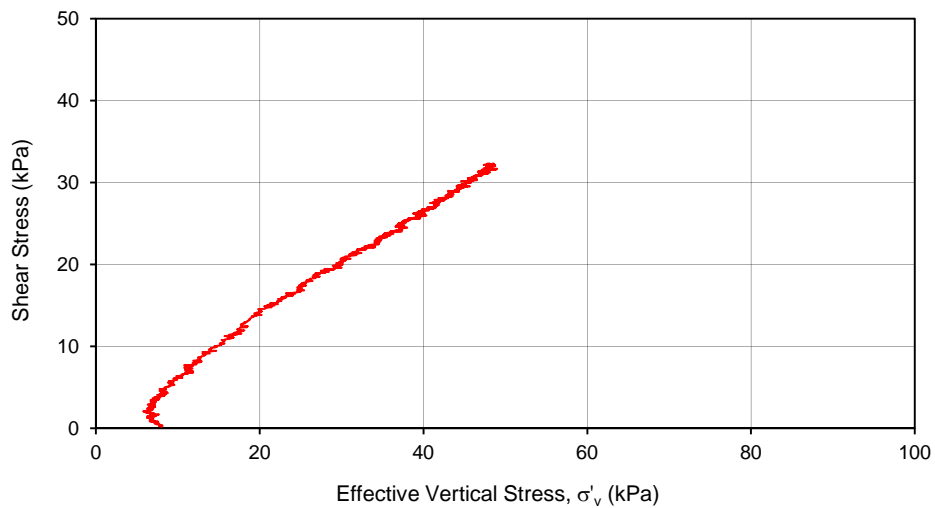
POST-CYCLIC STATIC SHEAR TEST

Note: Test performed after stress-controlled DSS test at average cyclic stress ratio, CSR = 0.60 with 84% excess pore pressure. Post-cyclic tests performed under initial condition of zero shear stress

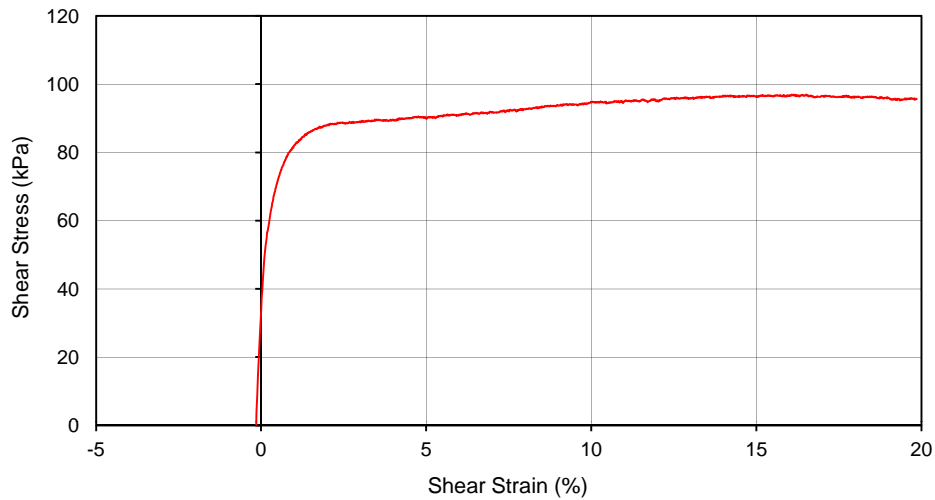
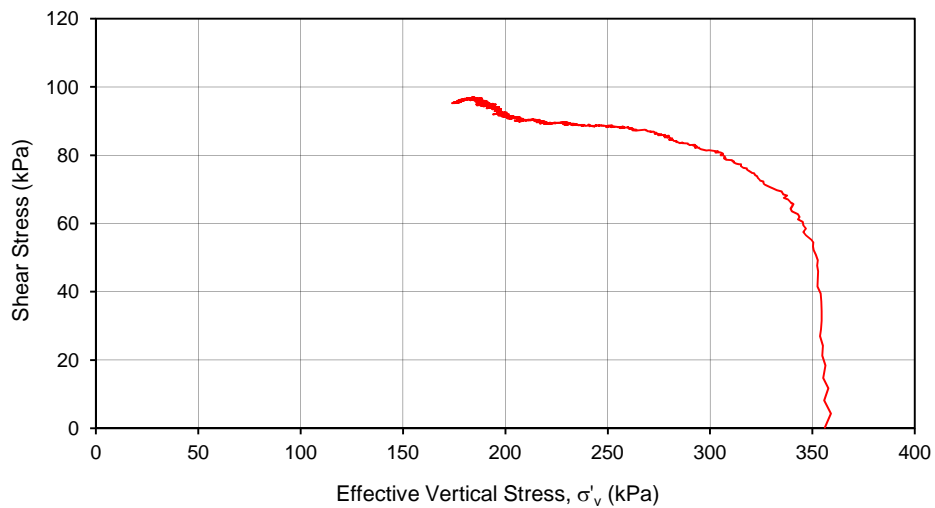
POST-CYCLIC STATIC SHEAR TEST

Note: Test performed after stress-controlled DSS test at average cyclic stress ratio, CSR = 0.10 with 16% excess pore pressure. Post-cyclic tests performed under initial condition of zero shear stress

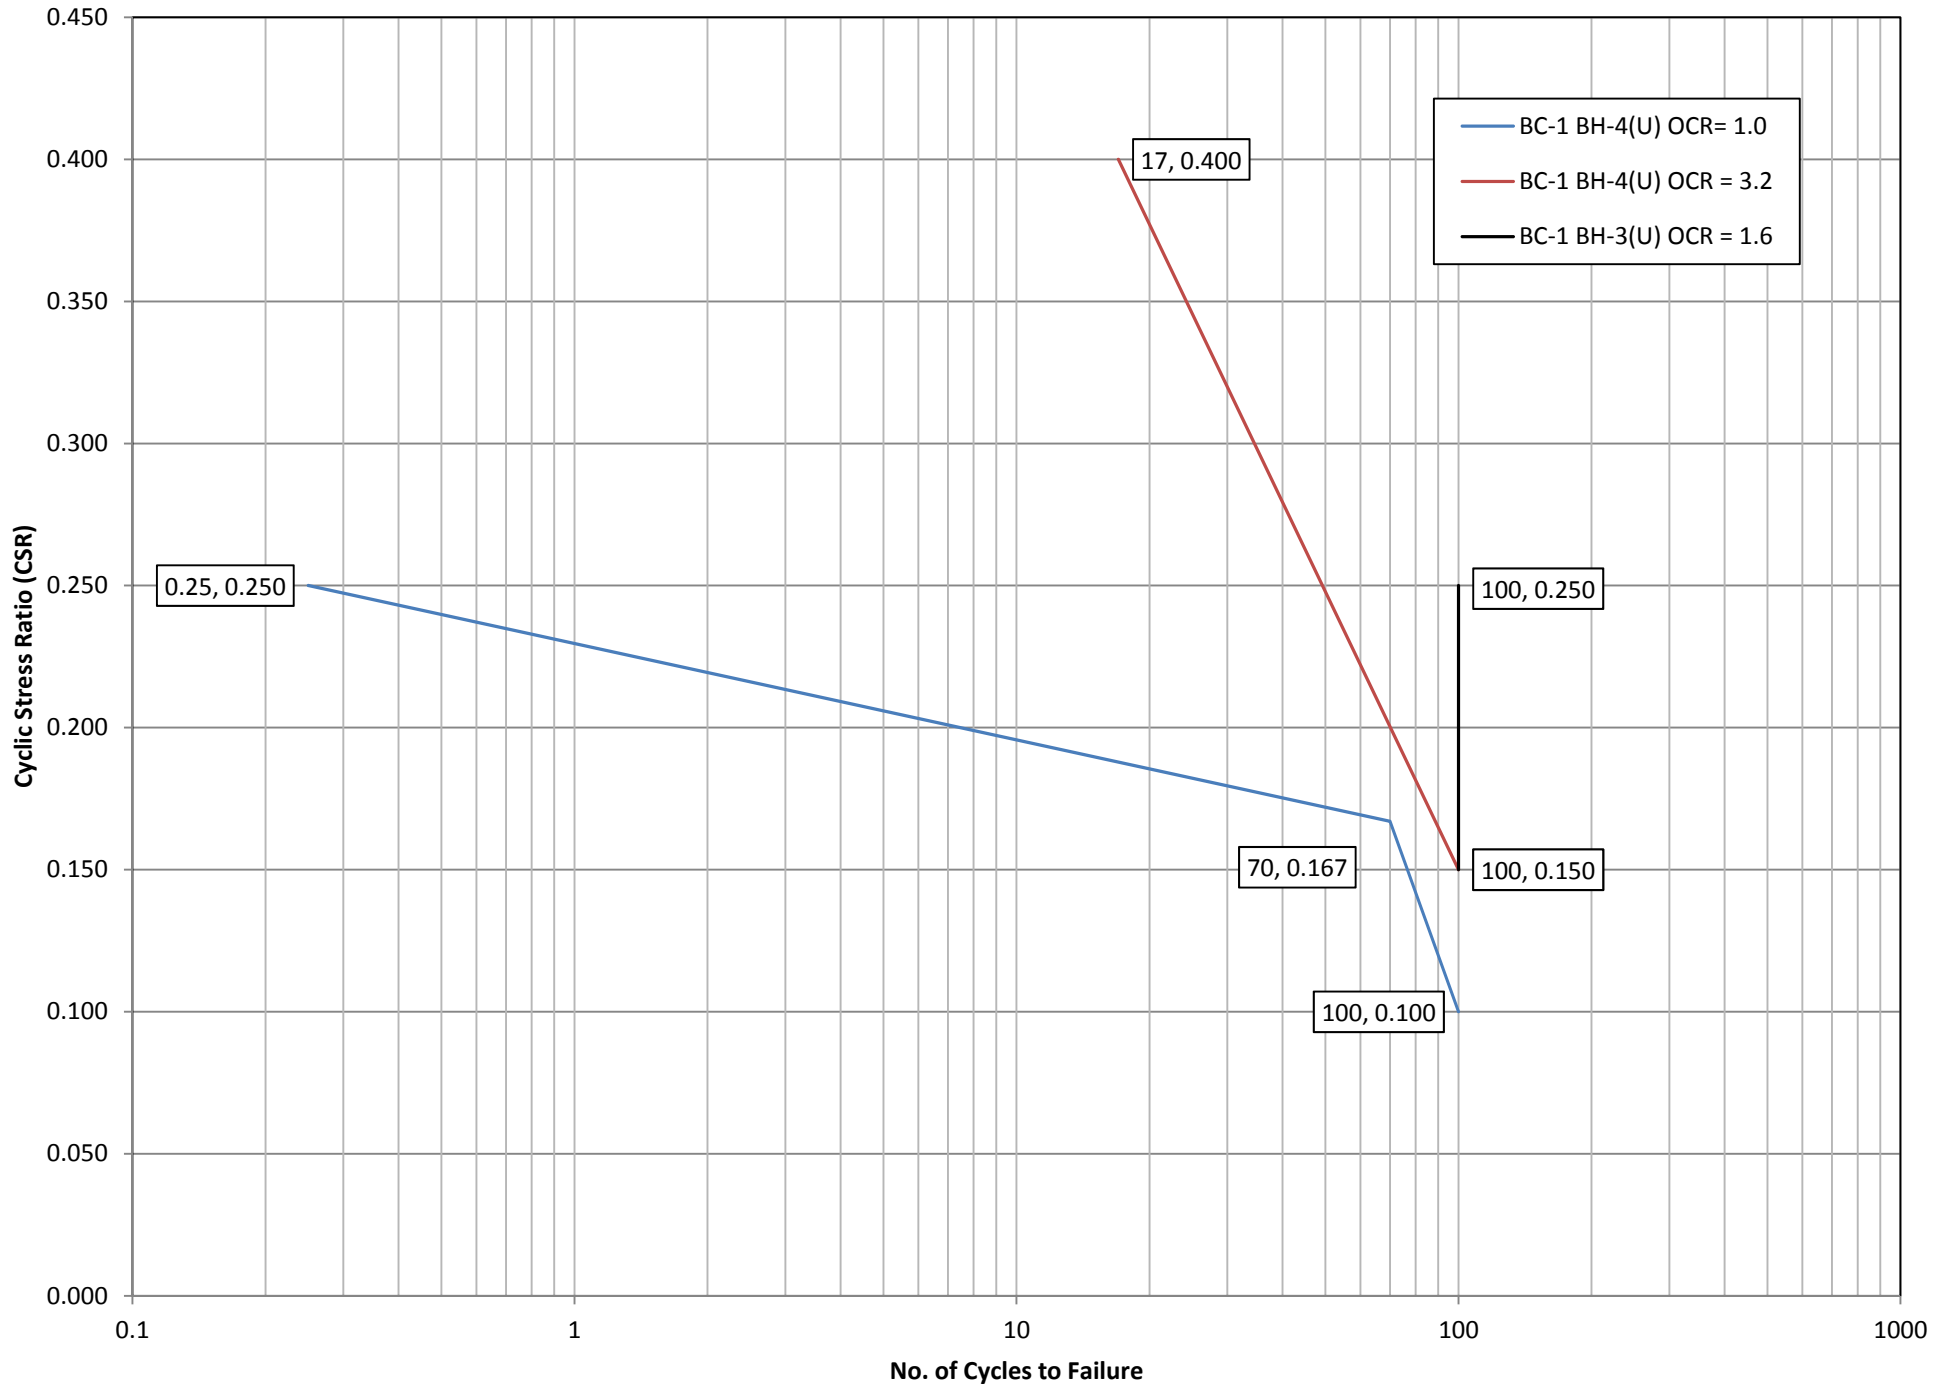
Cycles to Failure vs. Cyclic Stress Ratio (CSR)

Cyclic DSS (CycDSS) testing was performed to evaluate strength degradation with cyclic loading. Based on the CycDSS testing the soils appeared to have little to no strength degradation to 100 cycles and Post-CycDSS testing yielded soil strengths nearly the same as samples tested in static DSS. A strength reduction was evaluated by using Figure D-1.8 in Appendix D and the average plasticity index from the soils encountered. A reduction of 20 percent was conservatively used to degrade the strength properties from the peak undrained strength to the post-earthquake undrained strength.
